Equipment :	Bumper	Loss Type :		Defect Loss							KAIZEN IDEA SHEET Kaizen ID : 2438												
	Department :	Surface treatment	Result :		N	P	Q	C	D	S	M													
	Cell :	Powder coating	Type :																					
Unit Name :			112303 - NAHARS ENGINEERING INDIA PVT. LTD, Aurangabad			Operation :							Powder coating											
Kaizen Theme:			Reduce Jig-marks of hanger jigs in front side of Bumper (near hole)			Idea :							To create SINGLE POINT Contact between JIG Loading Hook and Bumper by Changing the Degree of "Loading Hook"											
Problem / Present Status			Counter Measure			Benchmark :		73%																
Jig-marks on front side of Bumper			Changing the Degree of "Loading Hook" from Angular to Semi-Circle			Target :		0 %																
						Start :		24/05/2014			Finished :		30/05/2014											
						Note :																		
						Team Members :

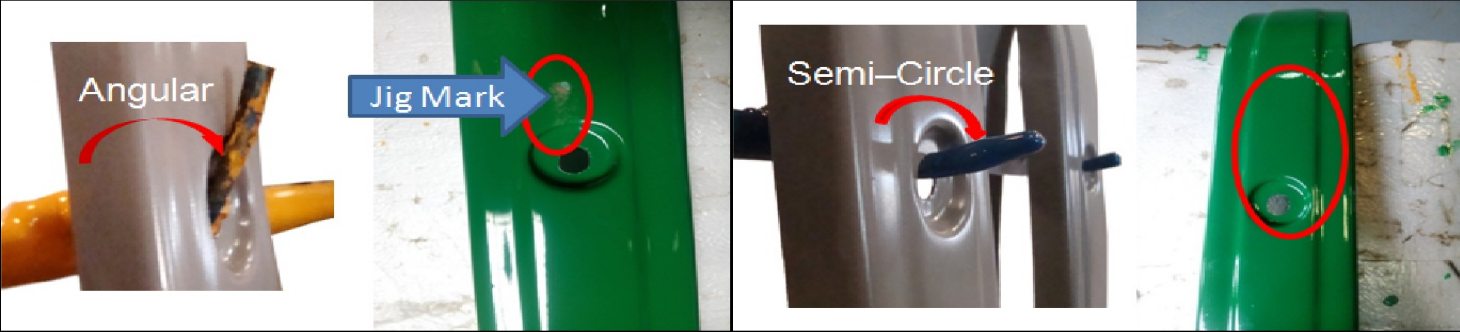
Material Cost	Labour Cost	Total																						
0.00	0.00	0.00																						
Equipmnet	Target	Status																						
Mudguard	30/09/2014	PROCESS																						
Root Cause			<div style="text-align: center;">

</div>																					
Multiple points contact between JIG Loading Hook and Bumper																								
Date :																								
Registered By :																								
Manager's Sign :																								
----- Bajaj Auto Ltd. (Fabrication) -----
