| | Equipment : | F-170 LH | Loss Type : | Defect Loss | | | | | | | KAIZEN IDEA SHEET | | | | | |
| Cell : K2/K3 frame | | | Operation : Robotic welding | | | | | | | | | | | | | |
| Kaizen Theme: To Eliminate IHR of Side Stand bkt fitment hard due to spatters in side stand bkt. hole | | | Idea : Antispatter protective guards provided for side stand bkt on F-170 stage. | | | | | | | | | | | | | |

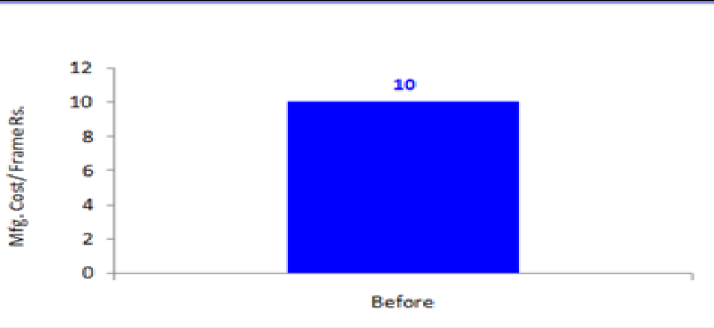
| Spatter enter in the side stand bkt hole at the time of welding on F-170 stage. | | | On F-170 stage antispatter protective guard provided on side stand bkt to avoid the spatter enter in the hole of Side stand bkt. | | | Target : | | Zero Nos. | | | | | | | | |
| W1 : Why Stand bkt fitment hard. ?<br>A1 : patter enters in the hole of side stand bkt<br>W2 : Why patter enters in the hole of side stand bkt ?<br>A2 : No protective guards on theside stand bkt hole at the time of welding.<br>W3 : Why No protective guards on theside stand bkt hole at the time of welding. ?<br>A3 :<br>W4 :<br>A4 : | | | Reduce the IHR Qty 10 frame to 0.<br><br> | | | What To Do : 1) Daily checking the clamping guard condition.<br>2) Wear out parts change on weekly.<br><br>How To Do : 1) By JH PM activity.<br><br>Frequency : Daily & Weekly<br><br>Cost Incurred For Making Kaizen : <table border="1"> <tr> <td>Material Cost</td> <td>Labour Cost</td> <td>Total</td> </tr> <tr> <td>80.00</td> <td>230.00</td> <td>310.00</td> </tr> </table> | | | | | Material Cost | Labour Cost | Total | 80.00 | 230.00 | 310.00 |
| Root Cause<br>No protective guards on theside stand bkt hole at the time of welding.<br><br>Date : 10/06/2014<br>Registered By : Mr. D M Sonawane<br>Manager's Sign : Mr. Arun Gawali | | | | | | Scope & Plan For Horizontal Deployment : <table border="1"> <tr> <td>Equipmnet</td> <td>Target</td> <td>Status</td> </tr> <tr> <td>F-170 RH</td> <td>23/06/2014</td> <td>COMPLETE</td> </tr> </table> | | | | | Equipmnet | Target | Status | F-170 RH | 23/06/2014 | COMPLETE |
