<b>Equipment :</b>	Head pipe manufacturing at tier.02	<b>Loss Type :</b>		Defect Loss							<b>KAIZEN IDEA SHEET</b>  <b>Kaizen ID : 2642</b>		
	<b>Department :</b>	QA	<b>Result :</b>		N	P	Q	C	D	S	M			
	<b>Cell :</b>	Boxer's frame line.	<b>Type :</b>											
<b>Unit Name :</b>			112933 - Metalman Auto Pvt Ltd., Aurangabad		<b>Operation :</b>								Head pipe manufacturing process at tier.02	
<b>Kaizen Theme:</b>			To prevent customer complaint of dent marks on head pipe at number punching area in boxer's		<b>Idea :</b>								Gravity conveyor for handling.	
<b>Problem / Present Status</b>			<b>Counter Measure</b>				<b>Benchmark :</b>		24					
During head pipe process , in material handling on press dent marks defect observed.			Gravity conveyor provided for material handling in process from press.01 to press.03				<b>Target :</b>		0

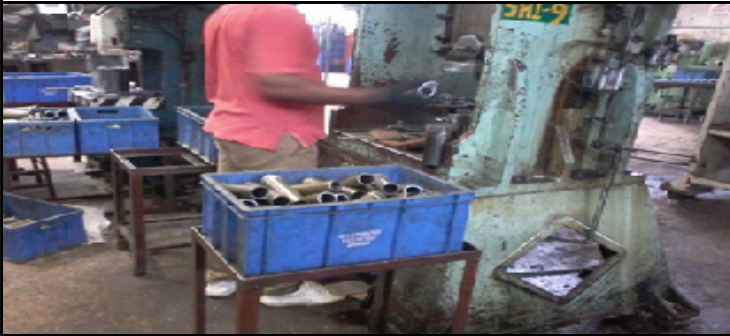
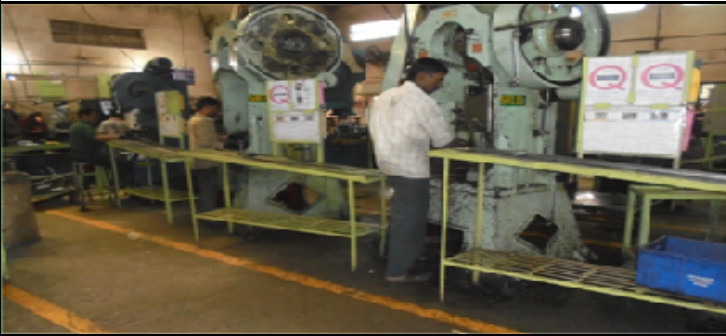
<b>Note :</b>		Improvement at tier.02 (Surya Auto)					
							<b>Team Members :</b>							
<b>Why Why Analysis :</b> W1 : Why Dent marks on number punching area ? A1 : during handling process on press W2 : Why during handling process on press ? A2 : material kept in bin so contact to contact touch material in bin W3 : Why material kept in bin so contact to contact touch material in bin ? A3 : No provision for material handling W4 : Why No provision for material handling ? A4 :			<b>Result :</b> Customer complaint zero from last 05 months.

<b>Kaizen Sustenance :</b>							
							What To Do : JH of material handling stand.							
							How To Do : by Audit							
<b>Root Cause</b> No provision for material handling  <b>Date :</b> 20/07/2015 <b>Registered By :</b> Mr. Lade D.S <b>Manager's Sign :</b> ----- Bajaj Auto Ltd. (Fabrication) -----							<b>Frequency :</b> Weekly / Monthly
