Equipment :	Forward Tack Stage	Loss Type :	Defect Loss							KAIZEN IDEA SHEET Kaizen ID : 2648						
	Department :	QA	Result :	N	P	Q	C	D	S	M							
	Cell :	CT100 frame line.	Type :														
Unit Name : 112933 - Metalman Auto Pvt Ltd., Aurangabad			Operation : Forward F-50 assly tack.														
Kaizen Theme: To prevent shabby welding defect on lower pipe joint in CT100 frame (CC- III rd party inspection).			Idea : Round to elliptical.														
Problem / Present Status		Counter Measure		Benchmark :		50											
During lower pipe welding in fixture, more gap observed & No scope for adjustment in forward tack welding fixture. (Round shape to tooling hole at LP		Fixture guidepin & lower pipe tooling hole provided elliptical against round.		Target :		0											
				Start :		28/05/2015		Finished :		30/05/2015							
				Note :		Kaizen on quality improvement , Implemented after approval from BAL - RND & Design.

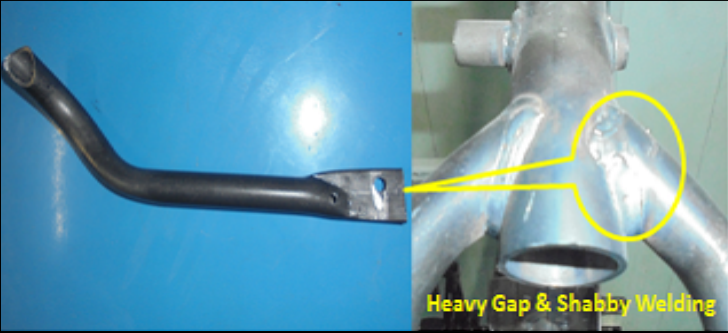
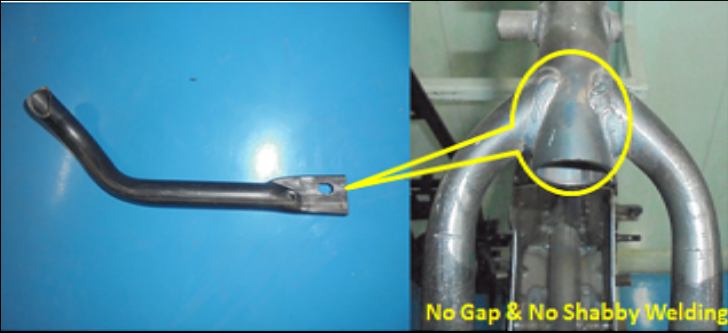
Why Why Analysis :		Result :		Kaizen Sustenance :													
W1 : Why Shabby welding at lower pipe joint. ? A1 : Heavy gap between main pipe & lower pipe joint. W2 : Why Heavy gap between main pipe & lower pipe joint. ? A2 : No scope for adjust & minimize gap in fixture. W3 : Why No scope for adjust & minimize gap in fixture. ? A3 : Round shape of tooling hole W4 : Why Round shape of tooling hole ? A4 :		Customer complaint zero & III rd party inspection stage rework zero after implementation.

Material Cost	Labour Cost	Total															
23000.00	3500.00	26500.00															
Root Cause Round shape of tooling hole				Scope & Plan For Horizontal Deployment : <table border="1"> <tr> <th>Equipmnet</th> <th>Target</th> <th>Status</th> </tr> <tr> <td>Forward tack assly</td> <td>10/06/2015</td> <td>COMPLETE</td> </tr> </table>								Equipmnet	Target	Status	Forward tack assly	10/06/2015	COMPLETE
Equipmnet	Target	Status															
Forward tack assly	10/06/2015	COMPLETE															
Date : 21/07/2015																	
Registered By : Mr. Lade D.S																	
Manager's Sign :																	
----- Bajaj Auto Ltd. (Fabrication) -----

What To Do : JH of fixture. How To Do : By Fix.maint auditor Frequency : Weekly / Monthly Cost Incurred For Making Kaizen : <table border="1"> <tr> <th>Material Cost</th> <th>Labour Cost</th> <th>Total</th> </tr> <tr> <td>23000.00</td> <td>3500.00</td> <td>26500.00</td> </tr> </table>								Material Cost	Labour Cost	Total	23000.00	3500.00	26500.00
