| Equipment : | Press machine die | Loss Type : | | Defect Loss | | | | | | | KAIZEN IDEA SHEET Kaizen ID : 2731 | | | | | | |
| | Department : | Maintenance | Result : | | N | P | Q | C | D | S | M | | | | | | | |
| | Cell : | Tool maintenance | Type : | | | | | | | | | | | | | | | |
| Unit Name : | | | 100264 - RUCHA ENGINEERING PVT LTD., Aurangabad | | | Operation : | | | | | | | Forming | | | | | |
| Kaizen Theme: | | | QUALITY IMPROVEMENT | | | Idea : | | To provide housing and guide pillar bush to pad | | | | | | | | | | |
| Problem / Present Status | | | Counter Measure | | | Benchmark : | | 850 | | | | | | | | | | |
| Collar not right angle in CBM tool | | | To Provide Housing & Guide Pillar Bush | | | Target : | | 0 | | | | | | | | | | |
| | | | | | | Start : | | 16/07/2015 | | | Finished : | | 17/07/2015 | | | | | |
|

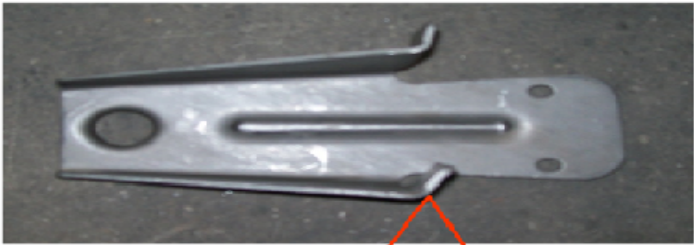
<p>Collar not right angle in CBM</p> | | | <p>Before Improvement</p>

<p>One Extra operation done separate for Collar Right Angle.</p> <p>After Improvement</p>

<p>Collar Right Angle In This Operation in one Die.</p> | | | Note : | | | | | | | | | | | | |
| | | | | | | Team Members : | | | | | | | | | | | | |
| | | | | | | 1. Tool maintenance tea | | 2. | | | | | | | | | | |
| | | | | | | 3. | | 4. | | | | | | | | | | |
| | | | | | | 5. | | 6. | | | | | | | | | | |
| | | | | | | Benefits | | | | | | | | | | | | |
| | | | | | | P | | Production per hour Nos 750.00 | | | | | | | | | | |
| | | | | | | C | | Per day one operator cost saved Rs 7800.00 | | | | | | | | | | |
| | | | | | | D | | lead time decreased in sec Nos 5.00 | | | | | | | | | | |
| Why Why Analysis : | | | Result : | | | Kaizen Sustenance : | | | | | | | | | | | | |
| W1 : Why Collar not right angle in CBM tool ? A1 : Due to load is on one side of pad W2 : Why Due to load is on one side of pad ? A2 : Pad goes one side during collar forming W3 : Why Pad goes one side during collar forming ? A3 : No housing to pad and guide pillar bush W4 : Why No housing to pad and guide pillar bush ? A4 : Not consider in tool design | | | Zero loss sustained
