| | Equipment : | Flxture | Loss Type : | Defect Loss | | | | | | | KAIZEN IDEA SHEET |
| Unit Name : 110865 - METALMAN MICRO TURNERS, | | | Operation : Robotic | | | | | | | | |
| Kaizen Theme: To eliminate customer complaint Engine mismatch in Pulsar-150 model | | | Idea : | | | | | | | | |

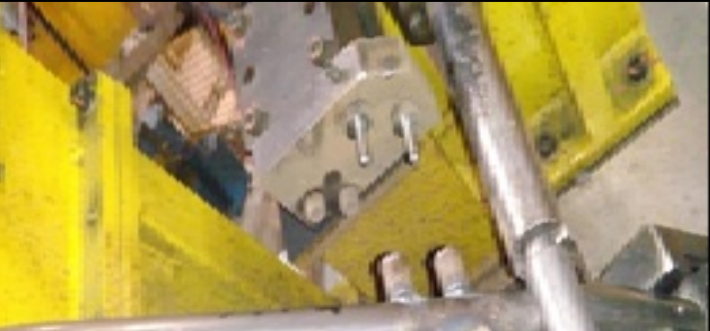
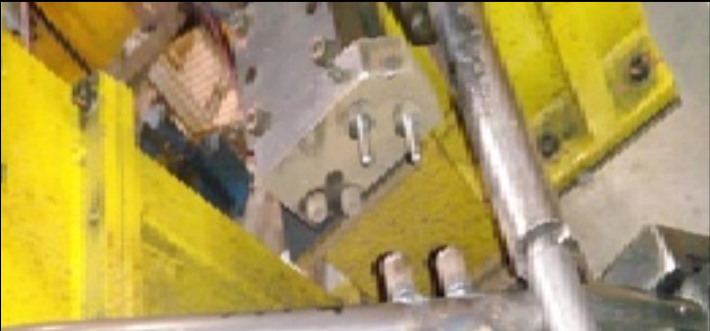
| Engine assly RH Rear bolt not align with rear engine mtg bush hole | | Bush locating pin length increased by 10 mm | | Target : | | 0 | | | | | |
| A2 : Rear engine bush out of position | | | | | | | | | | | |
| A3 : rear engine bush locating pin not guiding the bush | | | | Cost Incurred For Making Kaizen : | | | | | | | |
| A4 : Bush locating pin length less than half length of bush | | | | 50.00 | | 0.00 | | 50.00 | | | |
| Bush locating pin length less than half length of bush | | | | Equipmnet | | | | Target | | Status | |

| W1 : Why Engine miss match | | | | What To Do : Point added in Sustenance audit check sheet | | | | | | | |
