Equipment :	Fixture	Loss Type :	Defect Loss							KAIZEN IDEA SHEET Kaizen ID : 2868												
	Department :	QA	Result :	N	P	Q	C	D	S	M													
	Cell :	Fabrication	Type :																				
Unit Name : 110865 - METALMAN MICRO TURNERS,			Operation : Robotic																				
Kaizen Theme: To eliminate in-house defect Shocker bkt bend			Idea : Increase bkt location hole and pin Tolerance by .5 mm maximum																				
Problem / Present Status		Counter Measure		Benchmark :		20																	
Shocker bkt bend during clamping		pin dia decreased by .5 with chamfer provided		Target :		0

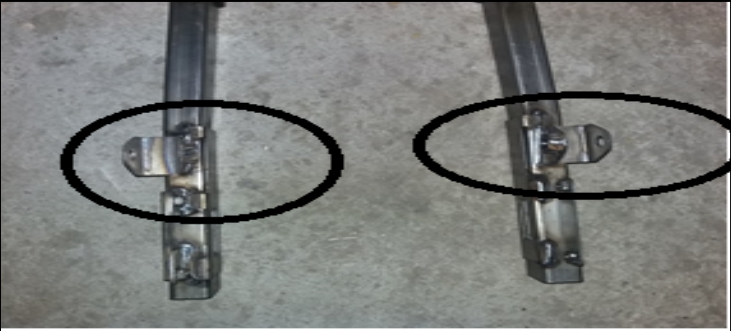
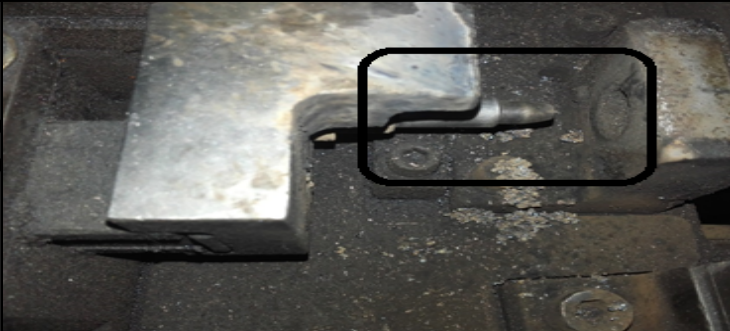
1. Amit Singh		2. Motilal																	
3. Dharmendra		4. nakul																					
5.		6.																					
Benefits																							
Why Why Analysis :		Result :		Kaizen Sustenance :																			
W1 : Why Shocker bkt bend ? A1 : locating pin not inserting fully into the shocker bkt W2 : Why locating pin not inserting fully into the shocker bkt ? A2 : Shocker bkt tilt after locating pin clamping W3 : Why Shocker bkt tilt after locating pin clamping ? A3 : Clamping pin hitting to shocker nut during clamping W4 : Why Clamping pin hitting to shocker nut during clamping ? A4 : Zero tolerance of locating pin and locating hole		Inhouse rework and rejection eliminated

Material Cost	Labour Cost	Total																					
0.00	0.00	0.00																					
Equipmnet	Target	Status																					
Root Cause Zero tolerance of locating pin and locating hole																							
Date : 05/06/2016																							
Registered By : Mr. Ajit Singh																							
Manager's Sign : MR Ajendra Giri																							
----- Bajaj Auto Ltd. (Fabrication) -----
