| | Equipment : | Tapping Fixture | Loss Type : | Defect Loss | | | | | | | KAIZEN IDEA SHEET<br><br>Kaizen ID : 509 |
| Unit Name : 107851 - AUTOCOMP CORPORATION PANSE PVT LTD, Pune | | | Operation : Tapping | | | | | | | | |
| Kaizen Theme: To eliminate steering lock bend problem at BAL for Pulsar 150 CC frame. | | | Idea : Proper Design | | | | | | | | |

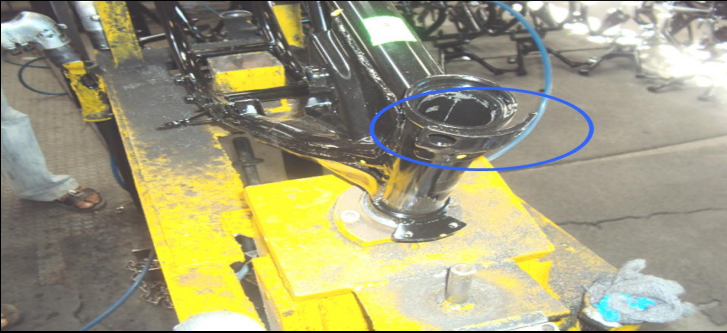
| Dimn 4.5 mm of the gap between head pipe & lock bkt obs 3 to 4.5 mm due to handling damage | | Provision of detection pokayoke in the tapping fixture | | Target : | | 0 | | | | | |
| W1 : Why Lock bkt with less gap going to customer ? | | Lock bkt gap less detection 100%. No customer complaint. | | What To Do : To check the detection pokayoke availability | | | | | | | |
| A1 : Inspection Skip | | | | | | | | | | | |
| A2 : Inspection dependency on inspector | | | | | | | | | | | |
| A3 : Manual (Add on) inspection | | | | Cost Incurred For Making Kaizen : | | | | | | | |
| A4 : Poor Design | | | | 0.00 | | 0.00 | | 0.00 | | | |
| Poor Design | | | | Equipmnet | | Target | | Status | | | |
