<b>Equipment :</b>	Serration Marking SPM	<b>Loss Type :</b>		Defect Loss							<b>KAIZEN IDEA SHEET</b>  <b>Kaizen ID : 510</b>						
	<b>Department :</b>	Weld shop	<b>Result :</b>		N	P	Q	C	D	S	M							
	<b>Cell :</b>	Swing Arm Fabrication - Platina	<b>Type :</b>															
<b>Unit Name :</b>			108302 - NEEL AUTO PRIVATE LIMITED-Pantnagar,			<b>Operation :</b>							Serration marking on center axle bracket					
<b>Kaizen Theme:</b>			Implementation of fool proofing on serration marking SPM to avoid wrong side of serration marking			<b>Idea :</b>												
<b>Problem / Present Status</b>			<b>Counter Measure</b>				<b>Benchmark :</b>		Zero occurrence of phenomenon									
Possibility of serration marking in opposite side.			Fool proofing provided in serration marking SPM to avoid wrong side serration marking.				<b>Target :</b>		Zero occurrence of phenomenon

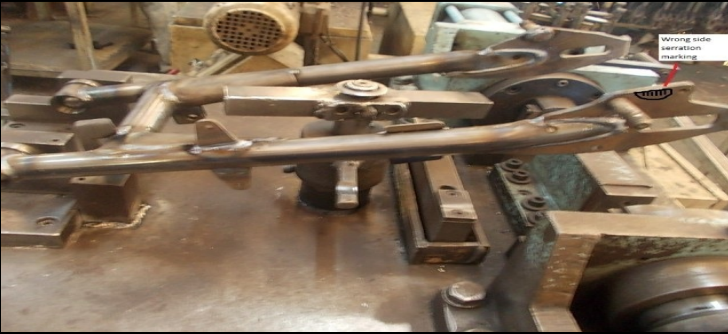
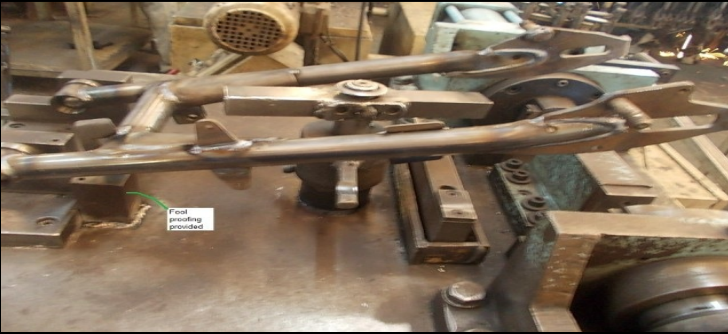
<b>Note :</b>		Done									
							<b>Team Members :</b>											
							1. Ashish Srivastava		2. Vikas		3. Yashpal		4.		5.		6.	
							<b>Benefits</b>											
							Q Wrong side serration marking phenomenon eliminated Nos 0.00											
<b>Why Why Analysis :</b>			<b>Result :</b>				<b>Kaizen Sustenance :</b>											
W1 : Why Possibility for wrong side serration marking on SPM ? A1 : Swing arm can be placed in serration marking SPM in upside down position W2 : Why Swing arm can be placed in serration marking SPM in upside down position ? A2 : No fool proofing provided in serration marking SPM W3 : A3 : W4 : A4 :			Wrong side serration marking phenomenon eliminated.

Material Cost	Labour Cost	Total																
200.00	100.00	300.00																
<b>Root Cause</b>							<b>Scope &amp; Plan For Horizontal Deployment :</b>											
No fool proofing provided in serration marking SPM							<table border="1"> <thead> <tr> <th>Equipmnet</th> <th>Target</th> <th>Status</th> </tr> </thead> <tbody> <tr> <td colspan="3" style="height: 100px;"></td> </tr> </tbody> </table>						Equipmnet	Target	Status			
Equipmnet	Target	Status																
<b>Date :</b>																		
<b>Registered By :</b>																		
<b>Manager's Sign :</b>																		
----- Bajaj Auto Ltd. (Fabrication) -----

What To Do : Daily monitoring of Poka Yoke  How To Do : Daily monitoring by poka Yoke verification sheet  Frequency : Daily  <b>Cost Incurred For Making Kaizen :</b> <table border="1"> <thead> <tr> <th>Material Cost</th> <th>Labour Cost</th> <th>Total</th> </tr> </thead> <tbody> <tr> <td>200.00</td> <td>100.00</td> <td>300.00</td> </tr> </tbody> </table>						Material Cost	Labour Cost	Total	200.00	100.00	300.00
