Equipment :	Rolling Machine	Loss Type :		Defect Loss							KAIZEN IDEA SHEET					
	Department :	Production	Result :	N	P	Q	C	D	S	M							
	Unit Name :	100199 - LAXMI RIKSHAW BODY PVT LTD, Aurangabad	Type :														
Cell :			Platina Silencer Assly.		Operation :								Rolling				
Kaizen Theme:			To eliminate Inhouse quality defect in Platina Rolled body due to welding burn.				Idea :						Bigger step OD of Metallic shaft of Rolling SPM				
Problem / Present Status			Counter Measure				Benchmark :										
In house rejection of Platina Rolled Muffler body, due to burn hole in TIG welding. Rejection part percentage was @ 5 % per month & rejection cost w			Changing bearing step OD of metallic shaft from existing 40 mm to 60 mm .				Target :

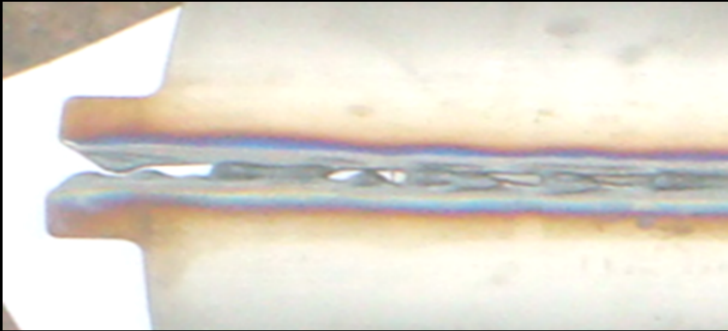
<div style="display: flex; justify-content: space-around;"> <div style="text-align: center;"> <p style="color: red;">Before Improvement:</p>

Note :										
							Team Members :										
							1.				2.						
							3.				4.						
5.				6.													
Benefits																	
C			saving cost of rejected muffler body Rs 118000.00														
Q			In house rejection of rolled muffler body due to burn hole in TIG welding is eliminated. Nos 1008.00														
Why Why Analysis :			Result :				Kaizen Sustenance :										
W1 : Why In house rejection of Rolled Muffler body due to burn hole, in TIG welding ? A1 : Gap between edges was more (observed 10 -12 mm against required 5 mm) after rolling. W2 : Why Gap between edges was more (observed 10 -12 mm against required 5 mm) after rolling. ? A2 : Less forming pressure between PU roller and metallic shaft W3 : Why Less forming pressure between PU roller and metallic shaft ? A3 : Step bearing OD of metallic shaft was weak to sustain forming load W4 : Why Step bearing OD of metallic shaft was weak to sustain forming load ? A4 : Bearing step OD of metallic shaft was less			In house rejection of rolled muffler body due to burn,hole in Tig welding is eliminated.
