Equipment :	Welding Machine.	Loss Type :	Defect Loss							KAIZEN IDEA SHEET												
	Department	QA	Result :	N	P	Q	C	D	S	M													
			Type :																				
Cell : KTM muffler fabrication cell.			Operation : Pipe B assy to transfer tube assy welding.																				
Kaizen Theme: To eliminate CC in KTM muff assy - Pipe B length undersize.			Idea : Poka yoke to be provided to arrest incomplete insertion of transfer tube locator.																				
Problem / Present Status		Counter Measure		Benchmark :		22																	
No provision to arrest incomplete insertion of transfer tube locator.		Proximity sensor provided to arrest incomplete insertion of transfer tube assy.		Target :		0																	
				Start :		20/04/2014		Finished :		23/04/2014													
				Note :																			
				Team Members :

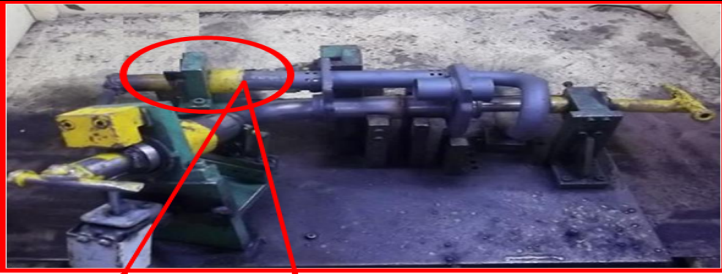
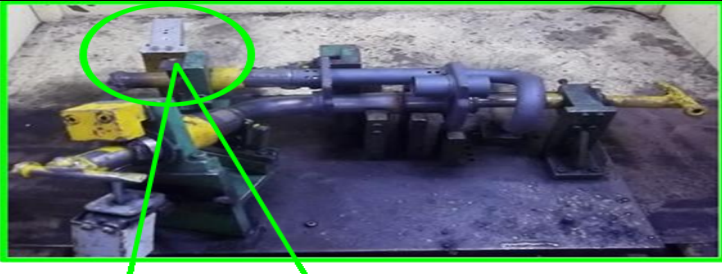
No provision to arrest incomplete insertion of transfer tube locator.		STOPPER & POKAYOKE SENSOR PROVIDED FOR LOCATING PIN OF PERFORATED TUBE																					
Why Why Analysis :		Result :		Kaizen Sustenance :																			
W1 : Why To eliminate CC in KTM muff assy - Pipe B length undersize. ? A1 : Pipe B length undersize during perforated body to transfer tube assy. W2 : Why Pipe B length undersize during perforated body to transfer tube assy. ? A2 : Transfer tube assy shifted downward side w.r.t tail pipe hole in perforated body assy stage. W3 : Why Transfer tube assy shifted downward side w.r.t tail pipe hole in perforated body assy stage. ? A3 : At transfertube assy stage transfer tube shifted to pipe B side W4 : Why At transfertube assy stage transfer tube shifted to pipe B side ? A4 : Transfer tube locator inserted incompletely.		Pipe B length undersize defect eliminated. <div style="text-align: center;"> CC trend - Pipe Length undersize.

</div>		What To Do : Working of proximity sensor. How To Do : Add in Poka yoke audit chek sheet. Frequency : Daily Cost Incurred For Making Kaizen : <table border="1" style="width: 100%;"> <tr> <th>Material Cost</th> <th>Labour Cost</th> <th>Total</th> </tr> <tr> <td>0.00</td> <td>0.00</td> <td>0.00</td> </tr> </table> Scope & Plan For Horizontal Deployment : <table border="1" style="width: 100%;"> <tr> <th>Equipmnet</th> <th>Target</th> <th>Status</th> </tr> <tr> <td> </td> <td> </td> <td> </td> </tr> </table>								Material Cost	Labour Cost	Total	0.00	0.00	0.00	Equipmnet	Target	Status

Material Cost	Labour Cost	Total																					
0.00	0.00	0.00																					
Equipmnet	Target	Status																					
Root Cause																							
No provision to arrest incomplete insertion of transfer tube locator.																							
Date : 20/04/2014																							
Registered By : Mr. D K Thorve																							
Manager's Sign : Mr Shivakumar																							
----- Bajaj Auto Ltd. -----
