Equipment :	Co2 Machine	Loss Type :	Defect Loss							KAIZEN IDEA SHEET
	Department :	Production	Result :	N	P	Q	C	D	S	M	
	Cell :	ROBOTICS	Type :								
Unit Name : 112303 - NAHARS ENGINEERING INDIA PVT. LTD, Aurangabad			Operation : Rear side panel fitment								Kaizen ID : 2338
Kaizen Theme: To prevent defect of wrong part fitment			Idea :								
Problem / Present Status		Counter Measure		Benchmark :		7 Qty					
Regular rear side panel fitted to Face Lift body		By providing additional locating block to bumper mounting hole in side panel to detect wrong part		Target :		0

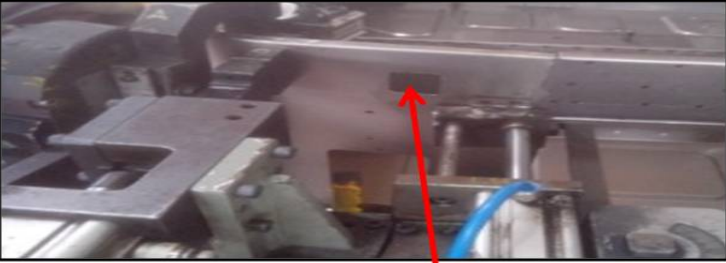
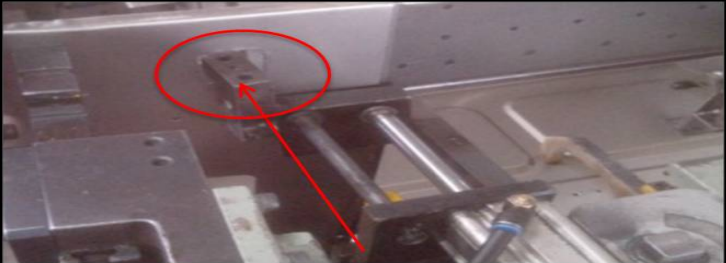
1. Mr. Dolas				2. Mr. Chandel			
				3. Mr. Paradhi				4. Mr. Ahire			
				5.				6.			
				Benefits							
No detection		Detection provided									
Why Why Analysis :		Result :		Kaizen Sustenance :							
W1 : Regular rear side panel fitted to FL body		IHR and CC reduced to zero		What To Do : By providing additional locating block to bumper mounting hole in side panel to detect wrong part							
A1 : Wrong part fitment in assly fixture at stage no. 14 Fixture A

How To Do : Daily poka-yoke audit							
W2 : Why Wrong part fitment in assly fixture at stage no. 14 Fixture A ?				Frequency : Daily							
A2 : Part mix-up				Cost Incurred For Making Kaizen :							
W3 : Why Part mix-up ?				Material Cost		Labour Cost		Total			
A3 : POKA				0.00		0.00		0.00			
W4 :				Scope & Plan For Horizontal Deployment :							
A4 :				Equipmnet		Target		Status			
Root Cause											
POKA											
Date : 19/08/2013
