| | Equipment : | floor tacking | Loss Type : | Defect Loss | | | | | | | KAIZEN IDEA SHEET<br><br>Kaizen ID : 2397 | |
| Unit Name : 100046 - YESHSHREE PRESS COMPS P LTD, Aurangabad | | | Operation : Floor Tacking | | | | | | | | | |
| Kaizen Theme: To Reduce Floor Spot Damage | | | Idea : Providing Support Below Floor Panel | | | | | | | | | |

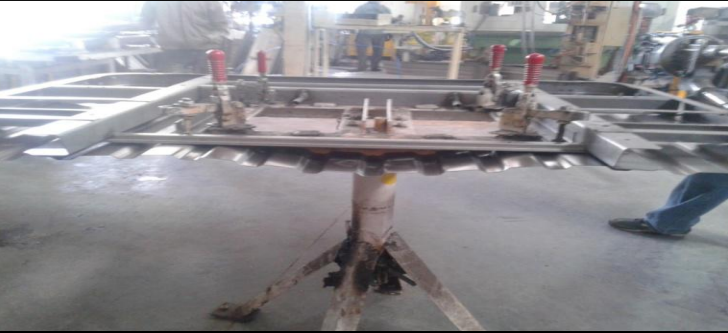
| Problem / Present Status | | Counter Measure | | | Benchmark : | | 100% | | | | | |
| Floor Spot Damage | | Support Provide Below Floor Panel | | | Target : | | zero | | | | | |
| W1 : W 1) Floor Spot Damage | | To Reduce Floor Spot Damage | | | What To Do : Add in JH Check Sheet | | | | | | | |
| A1 : A 1) Excessive Gap Between Floor and Frame | | | | | How To Do : Daily as per JH Check Sheet | | | | | | | |
| W2 : Why A 1) Excessive Gap Between Floor and Frame ? | | | | | Frequency : daily | | | | | | | |
| A2 : A 2) No Support Available Below Floor | | | | | Cost Incurred For Making Kaizen : | | | | | | | |
| A 2) No Support Available Below Floor | | | | | | | | | | | | |
