| | Equipment : | Joining Front and Rear Body | Loss Type : | Defect Loss | | | | | | | KAIZEN IDEA SHEET<br><br>Kaizen ID : 2399 | |
| Kaizen Theme: To Reduce Spatter Goes on Seat Mounting Stud | | | Idea : Providing Cover Seat Mounting Stud | | | | | | | | | |

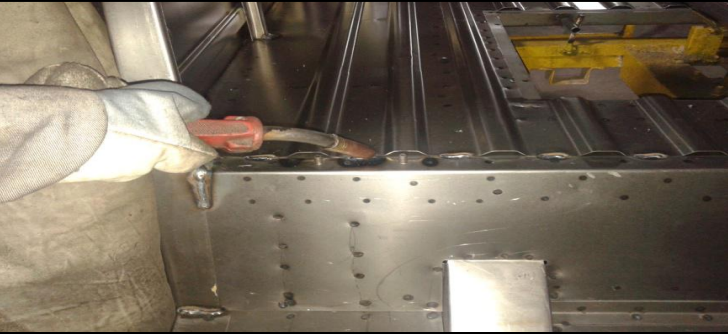
| Problem / Present Status | | Counter Measure | | | Benchmark : | | 100% | | | | | |
| W1 : W 1) Spatter Goes on Seat Mounting Stud | | Reduce spatter | | | What To Do : Add in Daily Quality Audit Check Sheet | | | | | | | |
| A1 : A 1) No Cover Available | | | | | | | | | | | | |
| A 1) No Cover Available | | | | | | | | | | | | |

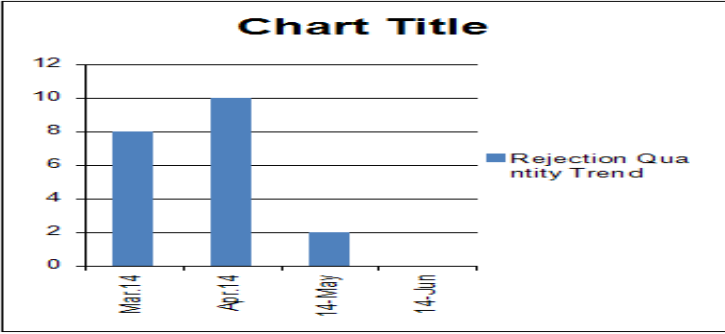
| Root Cause | | | | | | | | | | | | |
