| | Equipment : | Fixture-100 | Loss Type : | Defect Loss | | | | | | | KAIZEN IDEA SHEET |
| Kaizen Theme: To eliminate the Customer complaint set cowl clip mismatch. | | | Idea : Provide the cylinder for locate the lower clip position. | | | | | | | | |
| --- Bajaj Auto Ltd. (Fabrication) --- | | | | | Scope & Plan For Horizontal Deployment : | | | | | | |

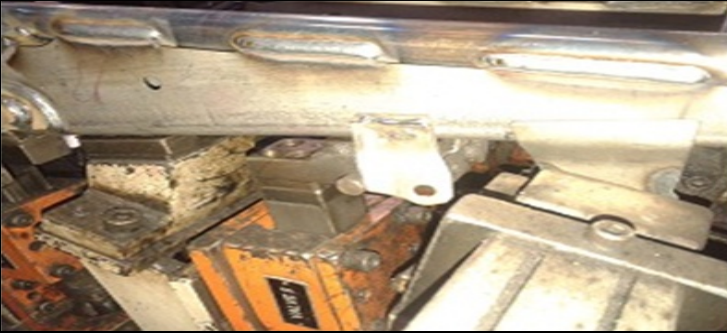
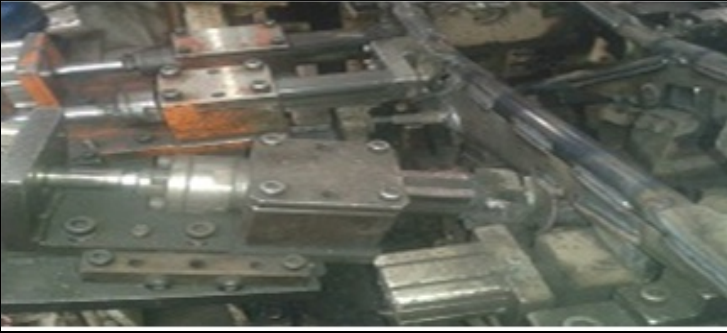
| Problem / Present Status | | Counter Measure | | | Benchmark : | | 209 | | | | |
| Seat Cowl Lower bkt mismatch with front seat cowl bracket | | Provison Of Cylinder to locate the lower clip hole position. | | | Target : | | 0 | | | | |
| W1 : Why Seat Cowl Clip mismatch ?<br>A1 : VARIation in lower seat cowl clip hole position.<br>W2 : Why VARIation in lower seat cowl clip hole position. ?<br>A2 : Location on bush OD.<br>W3 : Why Location on bush OD. ?<br>A3 : Poor Fixture Designen.<br>W4 : Why Poor Fixture Designen. ?<br>A4 : | | Control the Z-dim. of front air filter causing reduce the side panel mismatch. | | | What To Do : Use of Cylinder for seat cowl clip Location. | | | | | | |
| Root Cause<br>Poor Fixture Designen. | | | | | Frequency : | | | | | | |

| | | | | | How To Do : Use of Cylinder add in sustenance audit sheet. | | | | | | |
