<b>Equipment :</b>	PF181236 Tacking	<b>Loss Type :</b>		Defect Loss							<b>KAIZEN IDEA SHEET</b>  <b>Kaizen ID : 2573</b>												
	<b>Department :</b>	Subassemblies	<b>Result :</b>		N	P	Q	C	D	S	M													
	<b>Cell :</b>	Fairing	<b>Type :</b>																					
<b>Unit Name :</b>			112236 - BADVE ENGINEERING LIMITED. (2 Wh Waluj), Aurangabad			<b>Operation :</b>							Common bracket welding											
<b>Kaizen Theme:</b>			To eliminate Customer Complaint Of Fairing Mtg Lower Pivot PF181236 missing			<b>Idea :</b>							It should mandatory for operator to locate common bracket at its correct position before starting CO2 welding.											
<b>Problem / Present Status</b>			<b>Counter Measure</b>					<b>Benchmark :</b>																
Common bracket in Fairing mtg lower pivot found missing at customer end.			Provided Reed switch, Interlock with welding torch on pneumatic cylinder of welding fixture in such a way that if common bracket is not located opera					<b>Target :</b>

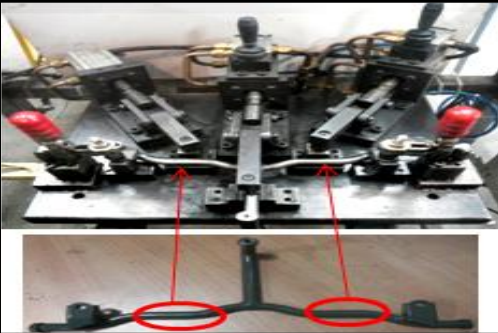
1. B.K. Jawale		2. A.P. Sasane														
								3. K.S. Jadhav		4.														
5.		6.																						
								<b>Benefits</b>																
								Q	Customer Complaint as well as IHR eliminated Rs 0.00															
								C	Cost of poor quality saved Rs 0.00															
								M	Moral of operator increased Rs 0.00															
<b>Why Why Analysis :</b>			<b>Result :</b>					<b>Kaizen Sustenance :</b>																
W1 : Why 03/03/2015 ?  A1 : Common Bracket in Fairing Mtg Lower Pivot found missing at customer end. W2 : Why Common Bracket in Fairing Mtg Lower Pivot found missing at customer end. ? A2 : Operator forget to locate comman bkt in welding fixture during tack welding. W3 : Why Operator forget to locate comman bkt in welding fixture during tack welding. ? A3 : W4 : A4 :								What To Do : Check working of reed switch & pneumatic cylinder shaft movement.  How To Do : Point added in daily JH check sheet.  Frequency : Daily  <b>Cost Incurred For Making Kaizen :</b> <table border="1"> <tr> <td>Material Cost</td> <td>Labour Cost</td> <td>Total</td> </tr> <tr> <td>5800.00</td> <td>0.00</td> <td>5800.00</td> </tr> </table> <b>Scope &amp; Plan For Horizontal Deployment :</b> <table border="1"> <tr> <td>Equipmnet</td> <td>Target</td> <td>Status</td> </tr> <tr> <td colspan="3"></td> </tr> </table>					Material Cost	Labour Cost	Total	5800.00	0.00	5800.00	Equipmnet	Target	Status

Material Cost	Labour Cost	Total																						
5800.00	0.00	5800.00																						
Equipmnet	Target	Status																						
<b>Root Cause</b>																								
Operator forget to locate comman bkt in welding fixture during tack welding.																								
<b>Date :</b> 25/02/2015 <b>Registered By :</b> Mr. A S Pawar <b>Manager's Sign :</b> Mr. D T RANE																								
----- Bajaj Auto Ltd. (Fabrication) -----
