Equipment :	Fixture	Loss Type :	Defect Loss							KAIZEN IDEA SHEET  Kaizen ID : 2584
	Department :	QA	Result :	N	P	Q	C	D	S	M	
	Cell :	Fabrication	Type :								
Unit Name : 110865 - METALMAN MICRO TURNERS,			Operation : Manual								
Kaizen Theme: To eliminate Seat cowl opposite fitment			Idea :								
Problem / Present Status		Counter Measure			Benchmark :						
Seat cowl opposite fitment		Provide Stopper pin at both side			Target :		0

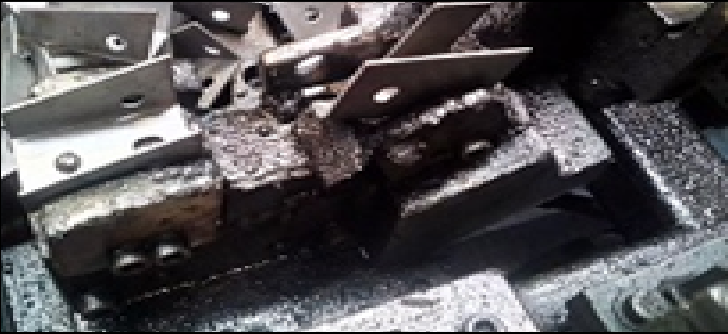
1. Amit singh		2. Harish				
					3. Mukesh		4. Ashish				
					5.		6.				
					Benefits						
					Q	Quality improved Rs 0.00					
Why Why Analysis :		Result :			Kaizen Sustenance :						
W1 : Why Seat cowl opposite fitment ? A1 : poka by welder W2 : Why poka by welder ? A2 : Same profile of seat cowl LH RH bkt not detect at fixture W3 : Why Same profile of seat cowl LH RH bkt not detect at fixture ? A3 : No arrangement at fixture to detect opposite bkt W4 : Why No arrangement at fixture to detect opposite bkt ? A4 :		Inhouse rework rejection eliminated regarding seat cowl opposite fitment			What To Do : Check stopper pin presence

How To Do : CTQ audit						
					Frequency : Daily						
					Cost Incurred For Making Kaizen :						
Root Cause					Scope & Plan For Horizontal Deployment :						
No arrangement at fixture to detect opposite bkt											
Date : 05/08/2014					Equipmnet      Target      Status
