Equipment :	HF-20	Loss Type :	Defect Loss							KAIZEN IDEA SHEET Kaizen ID : 2629
	Department :	Maintenance	Result :	N	P	Q	C	D	S	M	
	Cell :	Half Frame	Type :								
Unit Name : 113332 - Badve Engineering Ltd (CV Division), Aurangabad			Operation : Welding								
Kaizen Theme: To eliminate I.H.R. and to prevent CC due to driver seat bkt tilt			Idea : Tilting of driver seat bracket should be avoided								
Problem / Present Status		Counter Measure		Benchmark :		5 Occurance/Month					
Driver seat bracket tilt during welding		Driver seat bracket welding by using add on gauge		Target :		0					
				Start :		08/05/2015		Finished :		29/05/2015

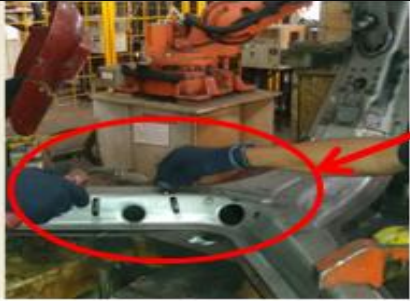
<div data-bbox="506 521 769 651" style="border: 1px solid blue; border-radius: 10px; padding: 5px; display: inline-block;"> Driver seat bracket welded without fixture </div>		<div style="border: 1px solid red; width: 15px; height: 15px; display: flex; align-items: center; justify-content: center;"> × </div>		Note :

Team Members :							
				1. Mr. Y.S. Rakhade		2. Mr. M.G. Ambhore					
				3. Mr. K.G. Narwade		4. Mr. A.B. Bangar					
				5.		6.					
				Benefits							
				C		Cost of rework saved Rs 0.00					
				Q		I.H.R. eliminated for particular phenomenon Rs 0.00					
Why Why Analysis :		Result :		Kaizen Sustenance :							
W1 : Why 29/05/2015 ?		I.H.R. eliminated due to driver seat bracket tilt		What To Do : Cleaning & checking							
A1 : Driver seat bracket welding by using add on gauge				How To Do : Through JH & PM							
W2 : Why Driver seat bracket welding by using add on gauge ?				Frequency : Daily & Weekly respectively							
A2 : Driver seat bracket tilt during welding				Cost Incurred For Making Kaizen :							
W3 : Why Driver seat bracket tilt during welding ?						Material Cost		Labour Cost		Total	
A3 : No provision of fix position to locate driver seat bracket						5000.00		500.00		5500.00

W4 : Why No provision of fix position to locate driver seat bracket ?				Scope & Plan For Horizontal Deployment :							
A4 :						Equipmnet		Target		Status	
Root Cause											
No provision of fix position to locate driver seat bracket											
Date : 08/05/2015											
Registered By : Mr. P P Videkar											
Manager's Sign : Mr. D T RANE											
----- Bajaj Auto Ltd. (Fabrication) -----
