Equipment : Lug cutting machine
Department : QA
Cell : Silencer

KAIZEN IDEA SHEET

Unit Name : 110865 - METALMAN MICRO TURNERS,

Kaizen Theme: To reduce the weld burn phenomenon at cone body and connector C

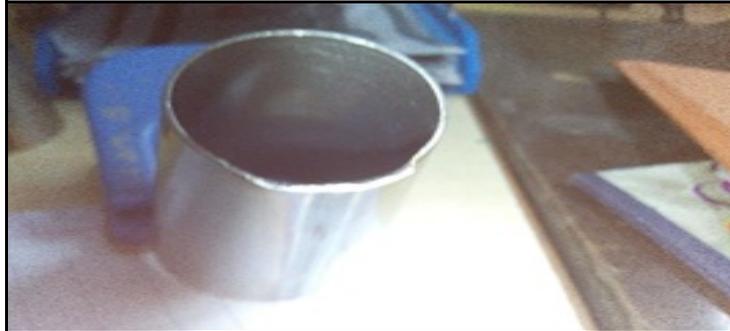
Problem / Present Status

Weld burn phenomenon at cone body and connector C

- W1 : Why Weld burn at the cone body and Connector C joint. ?
- A1 : Found th Gap Betwwen Cone body and connector C .
- W2 : Why Found th Gap Betwwen Cone body and connector C . ?
- A2 : Found the ovality during the lug cutting process.
- W3 : Why Found the ovality during the lug cutting process. ?
- A3 : Cone body expand the outer side .
- W4 : Why Cone body expand the outer side . ?
- A4 : Position of lug cutting is not ok

Position of lug cutting is not ok

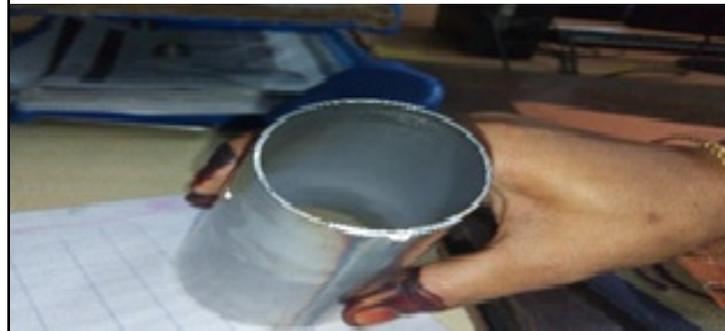
Result :

No weld burn
