| | Equipment : | ROBOTIC WELDING | Loss Type : | Defect Loss | | | | | | | <b>KAIZEN IDEA SHEET</b><br><br>Kaizen ID : 2977 |
| Unit Name : 113172 - BADVE AUTOCOMPS PVT LTD, Aurangabad | | | Operation : Body Muffler and Ex-Pipe A Round Welding | | | | | | | | |
| Kaizen Theme: To Reduce IHR due to Welding Leakage | | | Idea : Locating clearance should be less (45.80mm) | | | | | | | | |

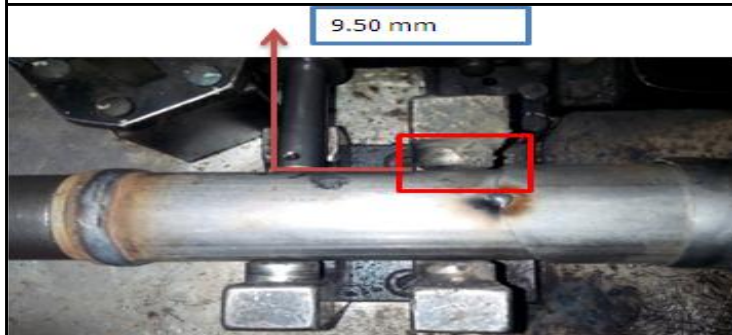
| Body Muffler and Ex-Pipe A welding leakage | | Locating button length increase from 9.50 - 10.0 mm | | Target : | | 0 | | | | | |
| A2 : Pipe B spacer edge not complete welded one side | | | | | | | | | | | |
| A3 : uneven gap between Pipe -B spacer & cover tube | | | | Cost Incurred For Making Kaizen : | | | | | | | |
| Locating clearance more (46.30 mm) | | | | | | | | | | | |

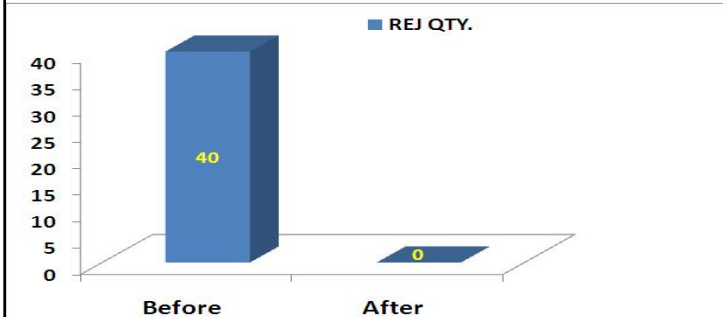
| W1 : Why Body Muffler and Ex-Pipe A welding leakage ? | | IHR Qty. Reduced from 40 nos. to 0 | | What To Do : Point Added in PM check sheet | | | | | | | |
