| | Equipment : | Welding fixture | Loss Type : | Defect Loss | | | | | | | KAIZEN IDEA SHEET<br><br>Kaizen ID : 3216 |
| Kaizen Theme: To eliminate the customer complaint Seat fitment hard | | | Idea : Fixture design modified | | | | | | | | |

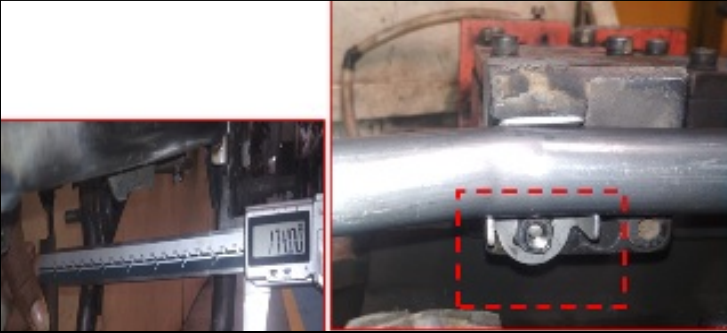
| Front seat cover bkt position shifted inside | | Supporting block providing to avoid the shifting inner side | | Target : | | 0 | | | | | |
| W1 : Why Front seat bkt position shift ?<br>A1 : Seat bkt Inner side dim. less observed by 4 mm<br>W2 : Why Seat bkt Inner side dim. less observed by 4 mm ?<br>A2 : Seat bkt shifted inner side by 4.5mm<br>W3 : Why Seat bkt shifted inner side by 4.5mm ?<br>A3 : No any stopper available on fixture for avoid the seat bkt shifting<br>W4 : Why No any stopper available on fixture for avoid the seat bkt shifting ?<br>A4 : | | Resolve Part shifting problem | | What To Do : Point Add to CTQ sheet | | | | | | | |
| Root Cause<br>No any stopper available on fixture for avoid the seat bkt shifting | | | | | | | | | | | |
