Equipment :	Spot welding machine	Loss Type :	Defect Loss							KAIZEN IDEA SHEET Kaizen ID : 516
	Department :	Quality	Result :	N	P	Q	C	D	S	M	
	Cell :	Fab 1	Type :								
Unit Name : 105139 - KESHARDEEP PRESSINGS, Aurangabad			Operation : Bkt Spot welding								
Kaizen Theme: To eliminate CC of G S Cover			Idea : Poka Yoke								
Problem / Present Status		Counter Measure		Benchmark :		6					
Bkt. Position Reverse to G S Cover		Providing Plate at locating notch to prevent reverse location		Target :		0					
				Start :		07/07/2013		Finished :		08/07/2013	
				Note :							
				Team Members :

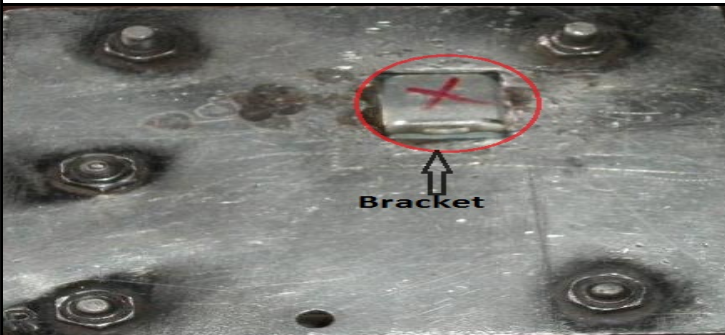
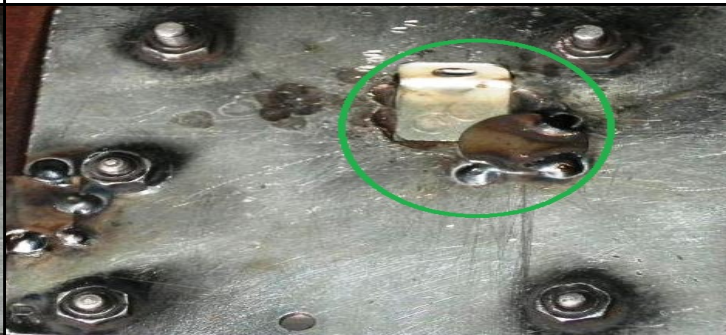
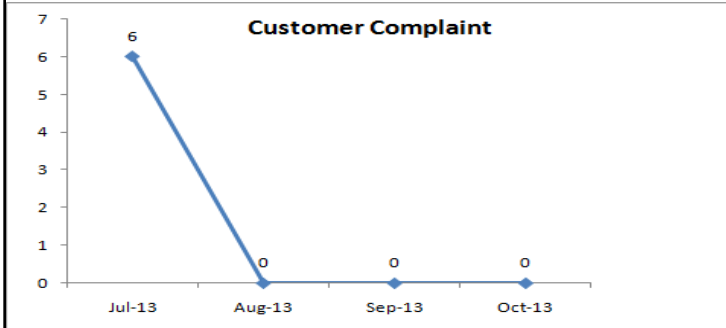
Root Cause											
Poka possibility in Bkt location											
Date : 07/07/2013											
Registered By : Mr. Santosh Bramhat											
Manager's Sign : Mr. Pratik Kankariya											
----- Bajaj Auto Ltd. (Fabrication) -----

1. Mr. Tambe				2. Mr. A Marodkar			
				3. Mr. S Bramhat				4.			
				5.				6.			
				Benefits							
				Q		IHR and Customer complaint Zero Nos 0.00					
				C		IHR cost reduction Rs 300.00					
Why Why Analysis :		Result :		Kaizen Sustenance :							
W1 : Why Bkt Position Reverse to G S Cover ?		Customer Complaint Zero		What To Do : Check for plate bend and damage							
A1 : Bkt reversely spot welded in welding fixture				How To Do : Visual inspection							
W2 : Why Bkt reversely spot welded in welding fixture ?				Frequency : Per Month							
A2 : Bkt reversely located in welding fixture				Cost Incurred For Making Kaizen :							
W3 : Why Bkt reversely located in welding fixture ?				Material Cost		Labour Cost		Total			
A3 : Poka possibility in Bkt location				5.00		20.00		25.00			
W4 : Why Poka possibility in Bkt location ?				Scope & Plan For Horizontal Deployment :							
A4 :				Equipmnet		Target		Status
