| | Equipment : | F-170 LH | Loss Type : | Defect Loss | | | | | | | KAIZEN IDEA SHEET | | | | | |
| Cell : K2/K3 frame | | | Operation : Robotic welding | | | | | | | | | | | | | |
| Kaizen Theme: To Eliminate IHR of Side Stand bkt fitment hard due to spatters in side stand bkt. hole | | | Idea : Antispatter protective guards provided for side stand bkt on F-170 stage. | | | | | | | | | | | | | |

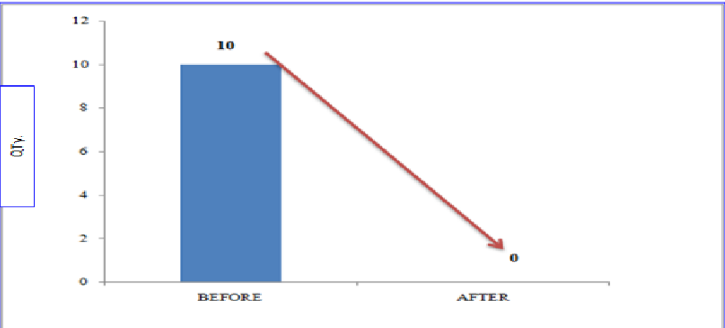
| W1 : Why Stand bkt fitment hard. ?<br>A1 : patter enters in the hole of side stand bkt<br>W2 : Why patter enters in the hole of side stand bkt ?<br>A2 : No protective guards on theside stand bkt hole at the time of welding.<br>W3 : Why No protective guards on theside stand bkt hole at the time of welding. ?<br>A3 :<br>W4 :<br>A4 : | | | Reduce the IHR Qty 10 frame to 0.<br><br> | | | What To Do : 1) Daily checking the clamping guard condition.<br>2) Wear out parts change on weekly.<br><br>How To Do : 1) By JH PM activity.<br><br>Frequency : Daily & Weekly<br><br>Cost Incurred For Making Kaizen : <table border="1"> <tr> <td>Material Cost</td> <td>Labour Cost</td> <td>Total</td> </tr> <tr> <td>80.00</td> <td>230.00</td> <td>310.00</td> </tr> </table> | | | | | Material Cost | Labour Cost | Total | 80.00 | 230.00 | 310.00 |
| Root Cause<br>No protective guards on theside stand bkt hole at the time of welding.<br><br>Date : 10/06/2014<br>Registered By : Mr. D M Sonawane<br>Manager's Sign : Mr. Arun Gawali | | | | | | Scope & Plan For Horizontal Deployment : <table border="1"> <tr> <td>Equipmnet</td> <td>Target</td> <td>Status</td> </tr> <tr> <td>F-170 RH</td> <td>23/06/2014</td> <td>COMPLETE</td> </tr> </table> | | | | | Equipmnet | Target | Status | F-170 RH | 23/06/2014 | COMPLETE |

| Spatter enter in the side stand bkt hole at the time of welding on F-170 stage. | | | On F-170 stage antispatter protective guard provided on side stand bkt to avoid the spatter enter in the hole of Side stand bkt. | | | Target : | | Zero Nos. | | | | | | | | |
