<b>Equipment :</b>	Head pipe manufacturing at tier.02	<b>Loss Type :</b>		Defect Loss							<b>KAIZEN IDEA SHEET</b>  <b>Kaizen ID : 2642</b>		
	<b>Department :</b>	QA	<b>Result :</b>		N	P	Q	C	D	S	M			
	<b>Cell :</b>	Boxer's frame line.	<b>Type :</b>											
<b>Unit Name :</b>			112933 - Metalman Auto Pvt Ltd., Aurangabad		<b>Operation :</b>								Head pipe manufacturing process at tier.02	
<b>Kaizen Theme:</b>			To prevent customer complaint of dent marks on head pipe at number punching area in boxer's		<b>Idea :</b>								Gravity conveyor for handling.	
<b>Problem / Present Status</b>			<b>Counter Measure</b>				<b>Benchmark :</b>		24					
During head pipe process , in material handling on press dent marks defect observed.			Gravity conveyor provided for material handling in process from press.01 to press.03				<b>Target :</b>		0

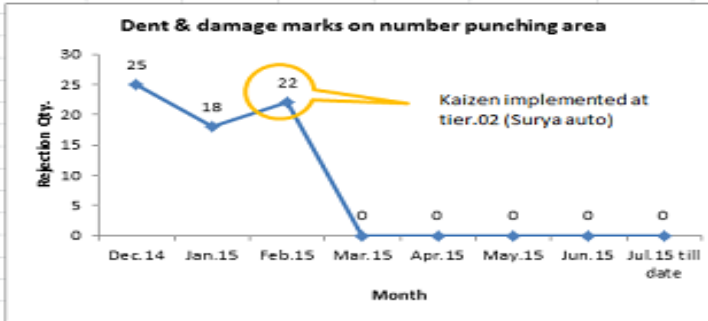
<b>Note :</b>		Improvement at tier.02 (Surya Auto)					
							<b>Team Members :</b>							
<b>Why Why Analysis :</b> W1 : Why Dent marks on number punching area ? A1 : during handling process on press W2 : Why during handling process on press ? A2 : material kept in bin so contact to contact touch material in bin W3 : Why material kept in bin so contact to contact touch material in bin ? A3 : No provision for material handling W4 : Why No provision for material handling ? A4 :			<b>Result :</b> Customer complaint zero from last 05 months.

<b>Kaizen Sustenance :</b>							
							What To Do : JH of material handling stand.							
							How To Do : by Audit							
<b>Root Cause</b> No provision for material handling  <b>Date :</b> 20/07/2015 <b>Registered By :</b> Mr. Lade D.S <b>Manager's Sign :</b> ----- Bajaj Auto Ltd. (Fabrication) -----							<b>Frequency :</b> Weekly / Monthly

<b>Cost Incurred For Making Kaizen :</b>							
							Material Cost		Labour Cost		Total			
12000.00		4000.00		16000.00										
							<b>Scope &amp; Plan For Horizontal Deployment :</b>							
							Equipmnet		Target		Status			
							Press.01 to 03		20/03/2015		COMPLETE
