Equipment :	Forward Tack Stage	Loss Type :	Defect Loss							KAIZEN IDEA SHEET Kaizen ID : 2648						
	Department :	QA	Result :	N	P	Q	C	D	S	M							
	Cell :	CT100 frame line.	Type :														
Unit Name : 112933 - Metalman Auto Pvt Ltd., Aurangabad			Operation : Forward F-50 assly tack.														
Kaizen Theme: To prevent shabby welding defect on lower pipe joint in CT100 frame (CC- III rd party inspection).			Idea : Round to elliptical.														
Problem / Present Status		Counter Measure		Benchmark :		50											
During lower pipe welding in fixture, more gap observed & No scope for adjustment in forward tack welding fixture. (Round shape to tooling hole at LP		Fixture guidepin & lower pipe tooling hole provided elliptical against round.		Target :		0											
				Start :		28/05/2015		Finished :		30/05/2015							
				Note :		Kaizen on quality improvement , Implemented after approval from BAL - RND & Design.

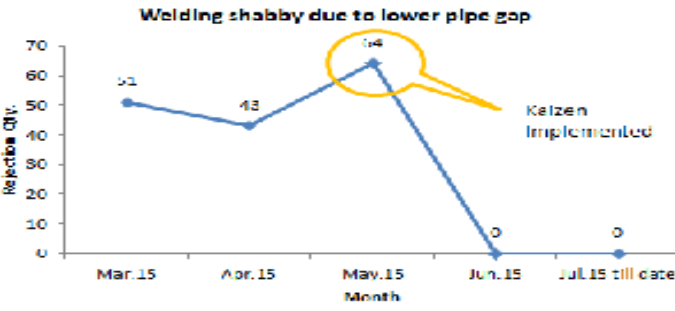
Why Why Analysis :		Result :		Kaizen Sustenance :													
W1 : Why Shabby welding at lower pipe joint. ? A1 : Heavy gap between main pipe & lower pipe joint. W2 : Why Heavy gap between main pipe & lower pipe joint. ? A2 : No scope for adjust & minimize gap in fixture. W3 : Why No scope for adjust & minimize gap in fixture. ? A3 : Round shape of tooling hole W4 : Why Round shape of tooling hole ? A4 :		Customer complaint zero & III rd party inspection stage rework zero after implementation.

Material Cost	Labour Cost	Total															
23000.00	3500.00	26500.00															
Root Cause Round shape of tooling hole				Scope & Plan For Horizontal Deployment : <table border="1"> <tr> <th>Equipmnet</th> <th>Target</th> <th>Status</th> </tr> <tr> <td>Forward tack assly</td> <td>10/06/2015</td> <td>COMPLETE</td> </tr> </table>								Equipmnet	Target	Status	Forward tack assly	10/06/2015	COMPLETE
Equipmnet	Target	Status															
Forward tack assly	10/06/2015	COMPLETE															
Date : 21/07/2015																	
Registered By : Mr. Lade D.S																	
Manager's Sign :																	
----- Bajaj Auto Ltd. (Fabrication) -----

What To Do : JH of fixture. How To Do : By Fix.maint auditor Frequency : Weekly / Monthly Cost Incurred For Making Kaizen : <table border="1"> <tr> <th>Material Cost</th> <th>Labour Cost</th> <th>Total</th> </tr> <tr> <td>23000.00</td> <td>3500.00</td> <td>26500.00</td> </tr> </table>								Material Cost	Labour Cost	Total	23000.00	3500.00	26500.00
