Equipment :	Fixture	Loss Type :	Defect Loss							KAIZEN IDEA SHEET Kaizen ID : 2868												
	Department :	QA	Result :	N	P	Q	C	D	S	M													
	Cell :	Fabrication	Type :																				
Unit Name : 110865 - METALMAN MICRO TURNERS,			Operation : Robotic																				
Kaizen Theme: To eliminate in-house defect Shocker bkt bend			Idea : Increase bkt location hole and pin Tolerance by .5 mm maximum																				
Problem / Present Status		Counter Measure		Benchmark :		20																	
Shocker bkt bend during clamping		pin dia decreased by .5 with chamfer provided		Target :		0

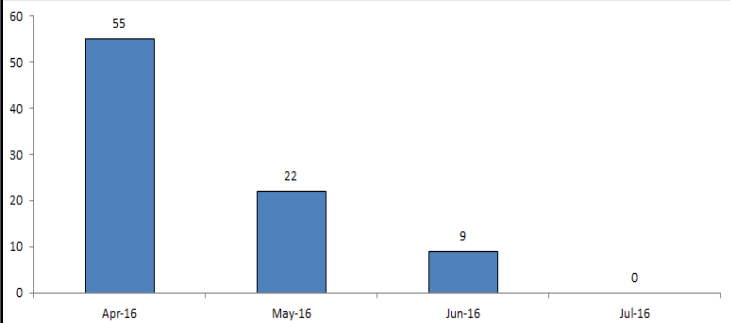
1. Amit Singh		2. Motilal																	
3. Dharmendra		4. nakul																					
5.		6.																					
Benefits																							
Why Why Analysis :		Result :		Kaizen Sustenance :																			
W1 : Why Shocker bkt bend ? A1 : locating pin not inserting fully into the shocker bkt W2 : Why locating pin not inserting fully into the shocker bkt ? A2 : Shocker bkt tilt after locating pin clamping W3 : Why Shocker bkt tilt after locating pin clamping ? A3 : Clamping pin hitting to shocker nut during clamping W4 : Why Clamping pin hitting to shocker nut during clamping ? A4 : Zero tolerance of locating pin and locating hole		Inhouse rework and rejection eliminated

Material Cost	Labour Cost	Total																					
0.00	0.00	0.00																					
Equipmnet	Target	Status																					
Root Cause Zero tolerance of locating pin and locating hole																							
Date : 05/06/2016																							
Registered By : Mr. Ajit Singh																							
Manager's Sign : MR Ajendra Giri																							
----- Bajaj Auto Ltd. (Fabrication) -----
