<b>Equipment :</b>	Serration Marking SPM	<b>Loss Type :</b>		Defect Loss							<b>KAIZEN IDEA SHEET</b>  <b>Kaizen ID : 510</b>						
	<b>Department :</b>	Weld shop	<b>Result :</b>		N	P	Q	C	D	S	M							
	<b>Cell :</b>	Swing Arm Fabrication - Platina	<b>Type :</b>															
<b>Unit Name :</b>			108302 - NEEL AUTO PRIVATE LIMITED-Pantnagar,			<b>Operation :</b>							Serration marking on center axle bracket					
<b>Kaizen Theme:</b>			Implementation of fool proofing on serration marking SPM to avoid wrong side of serration marking			<b>Idea :</b>												
<b>Problem / Present Status</b>			<b>Counter Measure</b>				<b>Benchmark :</b>		Zero occurrence of phenomenon									
Possibility of serration marking in opposite side.			Fool proofing provided in serration marking SPM to avoid wrong side serration marking.				<b>Target :</b>		Zero occurrence of phenomenon

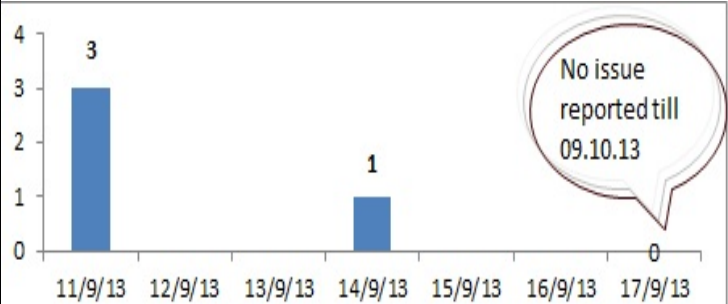
<b>Note :</b>		Done									
							<b>Team Members :</b>											
							1. Ashish Srivastava		2. Vikas		3. Yashpal		4.		5.		6.	
							<b>Benefits</b>											
							Q Wrong side serration marking phenomenon eliminated Nos 0.00											
<b>Why Why Analysis :</b>			<b>Result :</b>				<b>Kaizen Sustenance :</b>											
W1 : Why Possibility for wrong side serration marking on SPM ? A1 : Swing arm can be placed in serration marking SPM in upside down position W2 : Why Swing arm can be placed in serration marking SPM in upside down position ? A2 : No fool proofing provided in serration marking SPM W3 : A3 : W4 : A4 :			Wrong side serration marking phenomenon eliminated.

Material Cost	Labour Cost	Total																
200.00	100.00	300.00																
<b>Root Cause</b>							<b>Scope &amp; Plan For Horizontal Deployment :</b>											
No fool proofing provided in serration marking SPM							<table border="1"> <thead> <tr> <th>Equipmnet</th> <th>Target</th> <th>Status</th> </tr> </thead> <tbody> <tr> <td colspan="3" style="height: 100px;"></td> </tr> </tbody> </table>						Equipmnet	Target	Status			
Equipmnet	Target	Status																
<b>Date :</b>																		
<b>Registered By :</b>																		
<b>Manager's Sign :</b>																		
----- Bajaj Auto Ltd. (Fabrication) -----

What To Do : Daily monitoring of Poka Yoke  How To Do : Daily monitoring by poka Yoke verification sheet  Frequency : Daily  <b>Cost Incurred For Making Kaizen :</b> <table border="1"> <thead> <tr> <th>Material Cost</th> <th>Labour Cost</th> <th>Total</th> </tr> </thead> <tbody> <tr> <td>200.00</td> <td>100.00</td> <td>300.00</td> </tr> </tbody> </table>						Material Cost	Labour Cost	Total	200.00	100.00	300.00
