| | Equipment : | | Loss Type : | Defect Loss | | | | | | | KAIZEN IDEA SHEET<br><br>Kaizen ID : 2208 | | | | | | | | | | | | |
| Unit Name : 112236 - BADVE ENGINEERING LIMITED. (2 Wh Waluj), Aurangabad | | | Operation : welding | | | | | | | | | | | | | | | | | | | | |
| Kaizen Theme: To improve weld quality (Blow Holes) | | | Idea : By replaced PU tubes in Copper tubes | | | | | | | | | | | | | | | | | | | | |

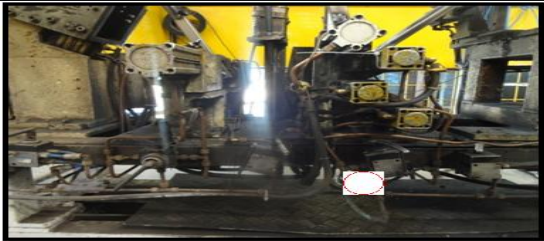
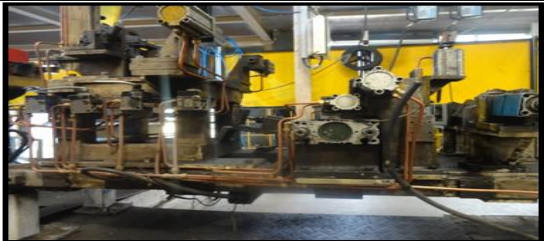
| Problem / Present Status | | Counter Measure | | | Benchmark : | | 915 per month CC PPM | | | | | | | | | | | | | | | | |
| Blow holes on welding joints. | | By replaced PU tube in Copper tubes. | | | Target : | | o | | | | | | | | | | | | | | | | |

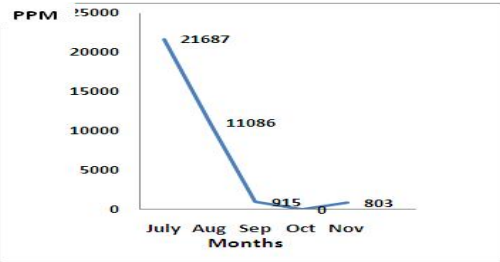
| W1 : Blow holes on welded joints.<br>A1 : .Air follows on the welding.<br>W2 : Why .Air follows on the welding. ?<br>A2 : .Air leakge from PU tubes.<br>W3 : Why .Air leakge from PU tubes. ?<br>A3 : PU tubes burn out due to hot spatter falls on them<br>W4 : Why PU tubes burn out due to hot spatter falls on them ?<br>A4 : PU tube burn due to spatter | | CC PPM Reduces<br><br> | | | What To Do :<br><br>How To Do :<br><br>Frequency :<br><br>Cost Incurred For Making Kaizen : <table><tr><td>Material Cost</td><td>Labour Cost</td><td>Total</td></tr><tr><td>3000.00</td><td>3000.00</td><td>6000.00</td></tr></table> Scope & Plan For Horizontal Deployment : <table><tr><td>Equipmnet</td><td>Target</td><td>Status</td></tr><tr><td colspan="3"></td></tr></table> | | | | | | | Material Cost | Labour Cost | Total | 3000.00 | 3000.00 | 6000.00 | Equipmnet | Target | Status | | | |
| Root Cause<br>PU tube burn due to spatter | | | | | | | | | | | | | | | | | | | | | | | |
