Equipment :	FRONT PANEL BPDY	Loss Type :	Defect Loss							KAIZEN IDEA SHEET												
	Department	QUALITY	Result :	N	P	Q	C	D	S	M													
			Type :																				
Cell : MEGA BODY			Operation : Front Panel Spotting																				
Kaizen Theme: To Eliminate Front panel spot dent/Damage ( CC )			Idea : Provide Copper plate to increase Contact area between panel & electrode.																				
Problem / Present Status		Counter Measure		Benchmark :		100%																	
Spot Dent marks observed in 'A' class area of Body because Panel length 1200mm & it is very difficult to balance while spotting on SSW-1		Copper Plate provided to eliminate spot dent marks.		Target :		0

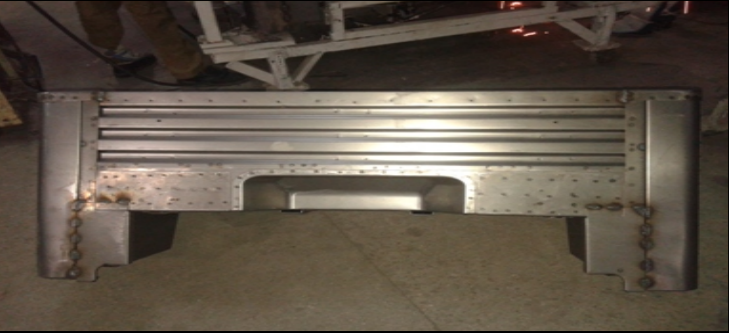
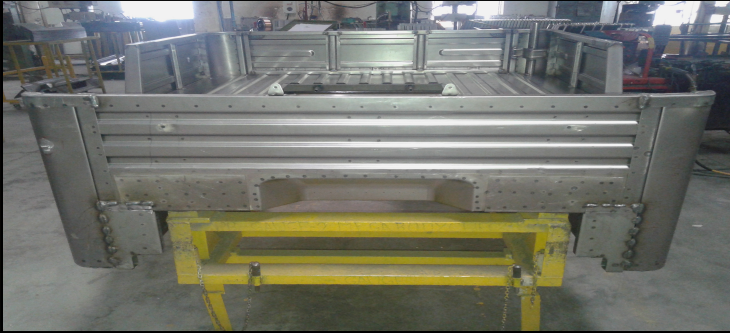
1. MR SUMIT SINGH		2. MR SWAPNIL TAMBEKAR																	
		3. MR AMOL PUND		4. MR NIVRUTTI SUKHASE																			
		5. MR S. WAGH		6.																			
				Benefits																			
				C		Save Cost of Rs 1500/Month Rs 0.00																	
				P		Save Change Over Time Rs 0.00																	
				Q		Eliminated Customer Complaint Rs 0.00																	
Why Why Analysis :		Result :		Kaizen Sustenance :																			
W1 : W1: Quality issues - a) Spot Weld Dent b) Spot Weld Damage c) Spot Weld Deep  A1 :  W2 : W2: 16mm Electode use it is Small for Spot Weld on Front Panel and Dent Mark Create A2 :  W3 : W3: Change the electrode and Fix Position Copper Plate use is not possible, because that electrode also use for mounting member spot weld A3 :  W4 : W4:Movable Copper Plate Use A4 :		No Dent marks observed on panel 100% job ok.

What To Do : Added in JH check sheet.  How To Do : DAILY MONITORING  Frequency :  Cost Incurred For Making Kaizen : <table><tr><td>Material Cost</td><td>Labour Cost</td><td>Total</td></tr><tr><td>0.00</td><td>0.00</td><td>0.00</td></tr></table> Scope & Plan For Horizontal Deployment : <table><tr><td>Equipmnet</td><td>Target</td><td>Status</td></tr><tr><td colspan="3"></td></tr></table>								Material Cost	Labour Cost	Total	0.00	0.00	0.00	Equipmnet	Target	Status
