Equipment :		Loss Type :	Defect Loss							KAIZEN IDEA SHEET
	Department	Production	Result :	N	P	Q	C	D	S	M	
			Type :								
Cell : BTX			Operation : Connecting tube cup welding								
Kaizen Theme: LMPW II-To prevent defect due to Connecting tube cup welding failure			Idea : Uniform insertion.								
Problem / Present Status		Counter Measure		Benchmark :		7 Inhouse Rejection qty.					
Connecting tube cup welding failure.		Fixture provided to ensure uniform insertion across periphery		Target :		0 Inhouse Rejection qty.					
				Start :		17/11/2013		Finished :		17/11/2013	
				Note :							
				Team Members :

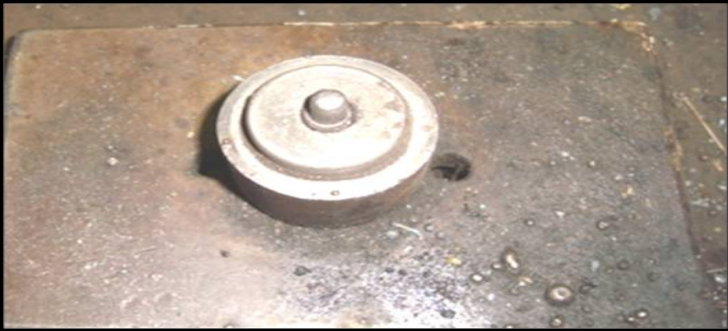
1. Mr. Ambhure				2. Mr. Bhalerao			
				3. Mr. Shinde				4.			
				5.				6.			
				Benefits							
				P		Productivity Increased Nos 0.00					
No Provision To Ensure Uniform Insertion

Why Why Analysis :		Result :		Kaizen Sustenance :							
W1 : Why Connecting tube cup welding failure. ? A1 : Tack welding is given away		Warranty complaint prevented & Reduce In-house Rework		What To Do : Fixture provided to ensure uniform insertion across periphery							
W2 : Why Tack welding is given away ? A2 : 4 nos. of welding tacks are not at two mating edges				How To Do : Daily audit by QA shift supervisor at every shift							
W3 : Why 4 nos. of welding tacks are not at two mating edges ? A3 : No uniform insertion				Frequency : Daily							
W4 : A4 :				Cost Incurred For Making Kaizen :							
				Material Cost		Labour Cost		Total

0.00		0.00		0.00			
				Scope & Plan For Horizontal Deployment :							
				Equipmnet				Target		Status	
Root Cause No uniform insertion											
Date : 16/11/2013											
Registered By : Mr. Rajkumar Kolhe											
Manager's Sign : Mr A K Trivedi											
----- Bajaj Auto Ltd. -----
