Equipment :	Satin Nickel	Loss Type :	Defect Loss							KAIZEN IDEA SHEET
	Department	Surfce Treatment	Result :	N	P	Q	C	D	S	M	
			Type :								
Cell : Electroplating			Operation : Electroplating								
Kaizen Theme: To eliminate pitting, spots in Electroplated parts			Idea : Baring provision to wheel								
Problem / Present Status		Counter Measure			Benchmark :		20%				
Cathode Movement fluctuates during process		By providing Ball bearing to wheel			Target :		0

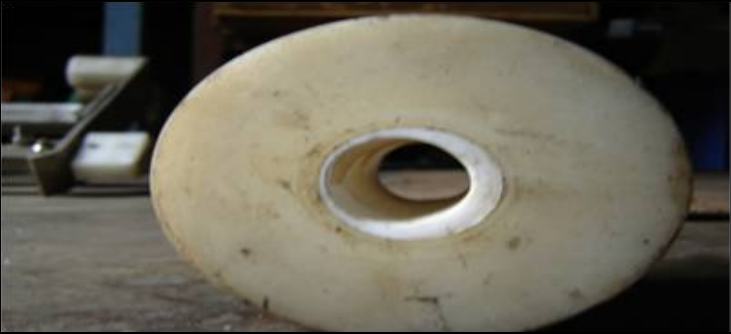
1. BB Raktate				2. Satish Kangire		
					3. Sanklesh Bichare				4. Ramdas Dabe		
					5.				6.		
Why Why Analysis :		Result :			Kaizen Sustenance :						
W1 : Why Spots and Pitting ? A1 : In-adequate plating W2 : Why In-adequate plating ? A2 : Satin Nickel Solution remains stagnant during process W3 : Why Satin Nickel Solution remains stagnant during process ? A3 : No mechanical movement within solution W4 : Why No mechanical movement within solution ? A4 : Cathode movement improper		Pitting and spot defects reduced			What To Do : Weekly PM						
Root Cause Wheel of cathode movement wear out

How To Do : By inspecting baring position						
Date : 15/07/2014					Frequency : Weekly						
Registered By : Mr. Rahul Deshpande					Cost Incurred For Making Kaizen :						
Manager's Sign : Mr. Nyayadhish											
----- Bajaj Auto Ltd. -----					Scope & Plan For Horizontal Deployment :						
					Equipmnet		Target		Status
