| | Equipment : | Frame Assembly | Loss Type : | Defect Loss | | | | | | | KAIZEN IDEA SHEET<br><br>Kaizen ID : 2471 |
| Unit Name : 112236 - BADVE ENGINEERING LIMITED. (2 Wh Waluj), Aurangabad | | | Operation : Welding | | | | | | | | |
| Kaizen Theme: To eliminate the engine bush tapping incomplete issue in frame assembly | | | Idea : All SPM welding parameter locked at specified | | | | | | | | |

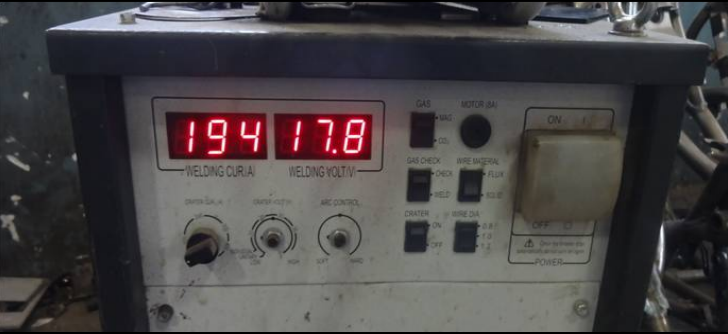
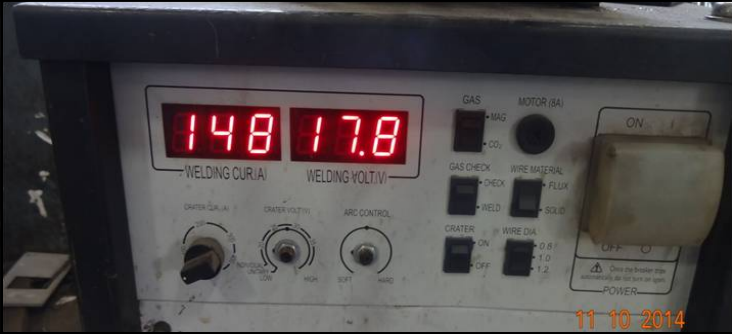
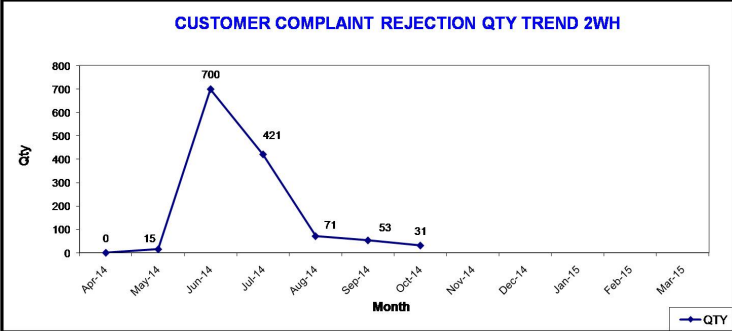
| Problem / Present Status | | Counter Measure | | Benchmark : | | 31/month | | | | | |
| welding parameters on higher side causing weld penetration inside bush. | | All SPM welding parameter locked at specified (Below 150 amps)parameter. (welding machine for SPM replaced with Inverter base Mogra m/c). | | Target : | | 0 | | | | | |
| W1 : Why Engine Bush tapping Incomplete ?<br>A1 : welding parameters on higher side causing weld penetration inside bush.<br>W2 : Why welding parameters on higher side causing weld penetration inside bush. ?<br>A2 : unlocking of welding parameters<br>W3 : Why unlocking of welding parameters ?<br>A3 :<br>W4 :<br>A4 : | | To reduce the CC about frame assembly | | What To Do : To Maintain check sheet | | | | | | | |
| Root Cause<br>unlocking of welding parameters | | | | | | | | | | | |

| | | | | How To Do : Add point in supervisor check sheet | | | | | | | |
