| | Equipment : | Bearing press | Loss Type : | Defect loss | | | | | | | KAIZEN IDEA SHEET<br><br>Kaizen ID : 2667 |
| Unit Name : AUTO PARTS, Jaisinghpur | | | Operation : Bearing press | | | | | | | | |
| Kaizen Theme: To eliminate the Bearing I.D U/S (Rocker Shaft not entre in bearing) customer complaint | | | Idea : Provision made to less wear of resting bush & Pin. | | | | | | | | |

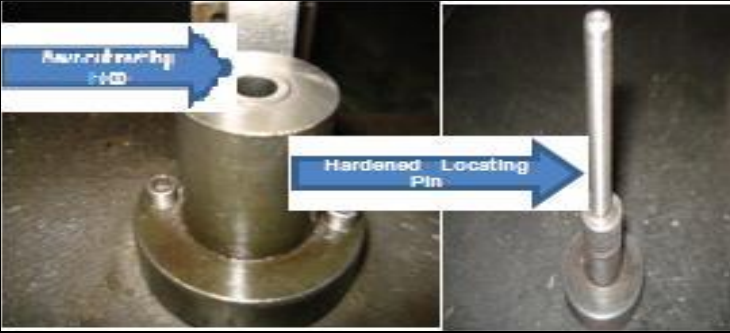
| Problem / Present Status | | Counter Measure | | Benchmark : | | 79 | | | | | |
| <b>Why Why Analysis :</b><br>W1 : Why Rocker shaft not enter in bearing ?<br>A1 : Bearing not fitted properly.<br>W2 : Why Bearing not fitted properly. ?<br>A2 : Pressing operation incorrect.<br>W3 : Why Pressing operation incorrect. ?<br>A3 : Resting face of fixture bush & locating pin dia.was wear out.<br>W4 : Why Resting face of fixture bush & locating pin dia.was wear out. ?<br>A4 :<br><br><b>Root Cause</b><br>Resting face of fixture bush & locating pin dia.was wear out.<br><br><b>Date :</b> 01/08/2013<br><b>Registered By :</b> Mr. S.A.Rayanade<br><b>Manager's Sign :</b> Mr. P.B.Patil | | <b>Result :</b> | | <b>Team Members :</b> | | | | | | | |
