Equipment :	F-40 stages	Loss Type :	Defect Loss							KAIZEN IDEA SHEET Kaizen ID : 2766
	Department :	Frame shop	Result :	N	P	Q	C	D	S	M	
	Cell :	Frame shop	Type :								
Unit Name : 100428 - BADVE AUTOCOMPS PVT LTD, Pune			Operation : WELDING								
Kaizen Theme: To improve the Visual appearance on full welding stage.			Idea : To Modify the block in Allen bolting condition.								
Problem / Present Status		Counter Measure		Benchmark :		5 NOS					
On K2-K3 line full welding stage visual appearance is not proper. Steering stopper block in welded condition.		To modify the full welding stage steering stopper block into Allen bolting condition.		Target :		zero

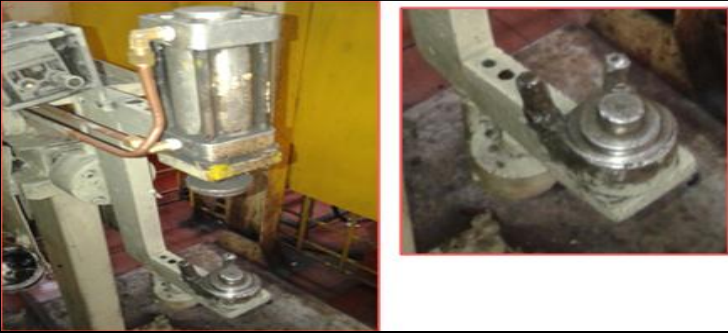
1. Mr.P.S.Kavhale		2. Mr.G.B.Dombe					
				3. Mr.Rahul Tajane		4.					
5.		6.									
Benefits											
P		Fixture Visual appearance Improve Nos 0.00									
M		Morale increased through 1S/2S Rs 0.00									
Why Why Analysis :		Result :		Kaizen Sustenance :							
W1 : K2-K3 line Full welding stage visual appearance is not proper.

What To Do : Weekly check the block condition through check point added in PM check sheet.							
A1 : Full welding stand steering stopper block in welded condition				How To Do : By PM activity							
W2 : Why Full welding stand steering stopper block in welded condition ?											
A2 : No provision for block in bolting condition.											
W3 : Why No provision for block in bolting condition. ?											
A3 :		Frequency : WEEKLY									
W4 :		Cost Incurred For Making Kaizen :									
A4 :		Material Cost		Labour Cost		Total

500.00		300.00		800.00					
Root Cause		No provision for block in bolting condition.		Scope & Plan For Horizontal Deployment :							
Date : 11/02/2016				Equipmnet		Target		Status			
Registered By : Mr. D M Sonawane											
Manager's Sign : Mr. Arun Gawali											
----- Bajaj Auto Ltd. (Fabrication) -----
