| | Equipment : | Fixture | Loss Type : | Defect Loss | | | | | | | <b>KAIZEN IDEA SHEET</b><br><br>Kaizen ID : 2884 | | | |
| Unit Name : 100264 - RUCHA ENGINEERING PVT LTD., Aurangabad | | | Operation : Spot welding | | | | | | | | | | | |
| Kaizen Theme: To prevent in house rework & rejection | | | Idea : Bottom reinforcement assembly in single stage | | | | | | | | | | | |

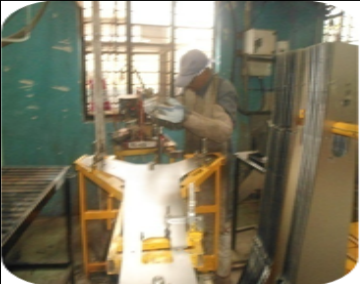
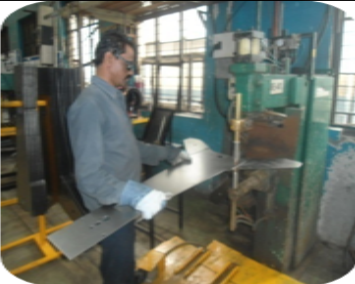
| Problem / Present Status | | | Counter Measure | | | | Benchmark : | | | | | | | |
| Spot welding operation missing material mix up | | | By providing special jig & welding fixture at spot welding machine | | | | Target : | | | | | | | |
