| | Equipment : | | Loss Type : | Defect Loss | | | | | | | KAIZEN IDEA SHEET<br><br>Kaizen ID : 2990 | | | | | | | | | | | | |
| Unit Name : 100189 - BADVE ENGINEERING LIMITED, | | | Operation : press M/c | | | | | | | | | | | | | | | | | | | | |
| Kaizen Theme: Minor cut observed at collar of sil case. | | | Idea : To be replaced the Die stripper plate | | | | | | | | | | | | | | | | | | | | |

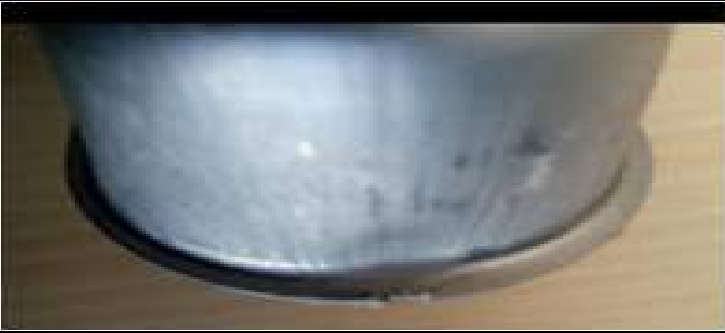
| Minor Cut Observed At Collar of The Sil Case Upper and Lower. | | To be replaced the Die stripper plate | | | | Target : | | | | | | | | | | | | | | | | | |

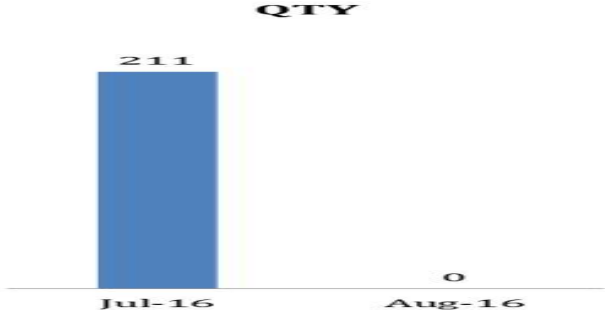
| W1 : Why Minor Cut Observed At Collar Of Sil Case. ?<br>A1 : Minor Cut Observed At Collar Of Sil Case Upper and Lower.<br>W2 : Why Minor Cut Observed At Collar Of Sil Case Upper and Lower. ?<br>A2 : Hyd Press Machine Cushion pin height variation.<br>W3 : Why Hyd Press Machine Cushion pin height variation. ?<br>A3 : Draw Die Stripper plat wear out.<br>W4 : Why Draw Die Stripper plat wear out. ?<br>A4 : Draw Die Stripper plat wear out. | | REJECTION REDUCE<br><br> | | | | What To Do : chenge the stripper die plate<br><br>How To Do : daily PM<br><br>Frequency : DAILY.<br><br>Cost Incurred For Making Kaizen : <table><tr><td>Material Cost</td><td>Labour Cost</td><td>Total</td></tr><tr><td>0.00</td><td>0.00</td><td>0.00</td></tr></table><br>Scope & Plan For Horizontal Deployment : <table><tr><td>Equipmnet</td><td>Target</td><td>Status</td></tr><tr><td>Hyd press M/c for Reso box Upp</td><td>23/02/2017</td><td>COMPLETE</td></tr></table> | | | | | | Material Cost | Labour Cost | Total | 0.00 | 0.00 | 0.00 | Equipmnet | Target | Status | Hyd press M/c for Reso box Upp | 23/02/2017 | COMPLETE |
| Root Cause<br>Draw Die Stripper plat wear out. | | | | | | | | | | | | | | | | | | | | | | | |

| Q | | No crack observed. Nos 0.00 | | | | | | | | | | | | | | | | | | | | | |
