Equipment :	place layout	Loss Type :	Defect Loss							KAIZEN IDEA SHEET  Kaizen ID : 2996
	Department :	SILENCER QUALITY	Result :	N	P	Q	C	D	S	M	
	Cell :	SA-80	Type :								
Unit Name : 110865 - METALMAN MICRO TURNERS,			Operation : Shot removal								
Kaizen Theme: To eliminate the whistle noise in silencer B104E at Bajaj auto limited			Idea : Change the layout.								
Problem / Present Status		Counter Measure		Benchmark :		0					
whistle noise in silencer		Change the layout in sequence of shot blasting area.		Target :

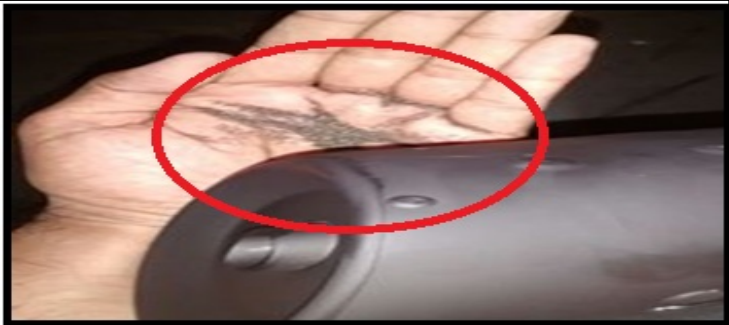
1. MR. SARVESH KUMAR		2. MR. SANJEEV KUMAR					
				3. MR. MUKESH KUMAR		4. MR. moh . Dilshad					
5. MR. ANURAG		6. MR. MAHESH PANT									
Benefits											
Why Why Analysis :		Result :		Kaizen Sustenance :							
W1 : Why whistle noise in silencer ? A1 : Shot or grit inside the silencer W2 : Why Shot or grit inside the silencer ? A2 : Shot not removed in silencer W3 : Why Shot not removed in silencer ? A3 : Silencer By pass without shot removal operation. W4 : Why Silencer By pass without shot removal operation. ? A4 : Possibility to mix up without shot removal silencer and shot blasting silencer.				What To Do :							
				How To Do :							
				Frequency :							
				Cost Incurred For Making Kaizen :							
				Material Cost		Labour Cost		Total

50.00		250.00		300.00			
				Scope & Plan For Horizontal Deployment :							
				Equipmnet				Target		Status	
Root Cause Layout design not effected or poor.											
Date : 28/10/2016											
Registered By : Mr. Sanjeev Kumar											
Manager's Sign : MR Ajendra Giri											
----- Bajaj Auto Ltd. (Fabrication) -----
