Equipment :	500 T press	Loss Type :	Other							KAIZEN IDEA SHEET
	Department :	Maintenance	Result :	N	P	Q	C	D	S	M	
	Cell :	Press Shop	Type :								
Unit Name : Rucha Engineers Pvt Ltd Plant 7, Aurangabad			Operation :								
Kaizen Theme: To prevent the oil leakage from ram holes			Idea : To fix the nylon bush with `O` ring in ram holes to prevent oil coming out from the holes								
Problem / Present Status		Counter Measure			Benchmark :						
Oil leakage from ram holes which falling on die & bolster plates as creating unsafe area & wastage of the oil		Fitted the nylon bush with the `O` ring in the ram holes to prevent the oil coming out .			Target :

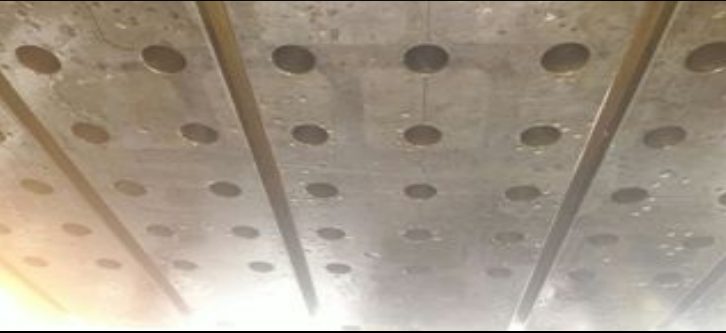
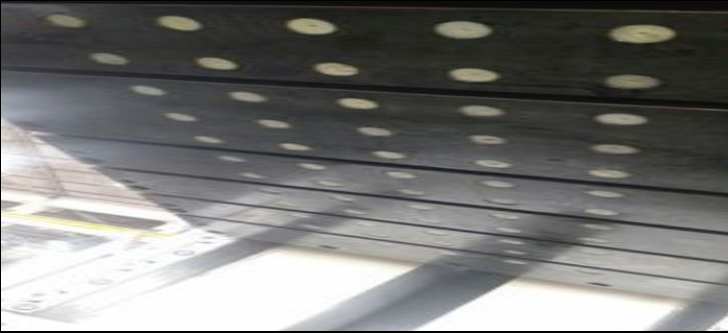
1. M.M. Naphade sir		2. S.N. Ingle				
3. A.B. Patil		4. V.M Mali									
5. K.D. Pawar		6. B.S. Dudhe									
Benefits											
M		Improved safe working condition at the machine area & Wastage of oil due to leakage also stopped . Days 0.00									
Why Why Analysis :		Result :			Kaizen Sustenance :						
W1 : Why Oil leakage from ram hole of 500 T press. ? A1 : As no provision to stop the oil coming out from ram holes . W2 : Why As no provision to stop the oil coming out from ram holes . ? A2 : OEM design. W3 : Why OEM design. ? A3 : W4 : A4 :		Oil leakage from ram holes stopped . This work improved safe production working condition & wastage of oil due to leakage also stopped .

What To Do : To observe the bush `O` Ring						
Root Cause OEM design.					How To Do : Through JH activity						
Date : 09/11/2017					Frequency : Daily						
Registered By : Rucha Engineers Pvt Ltd Plant 7					Cost Incurred For Making Kaizen :
