| | Equipment : | Full Welding | Loss Type : | | | | | Defect Loss | | | | | KAIZEN IDEA SHEET | | | | | | | | | | | |
| Kaizen Theme: To eliminate rejection for Welding lumps at main member ,lower part & lower reinforcement joining | | | Idea : No mannual error | | | | | | | | | | | | | | | | | | | | | |

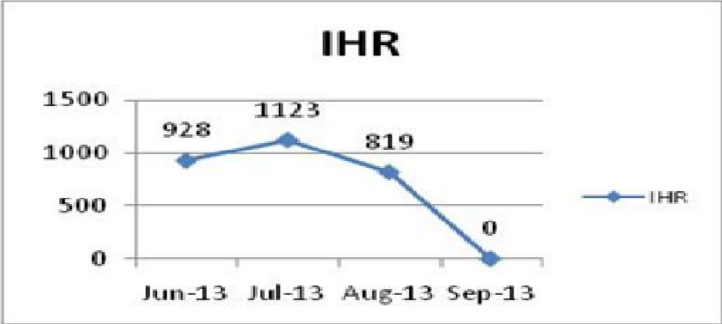
| | Equipment : | Full Welding | Loss Type : | | | | | Defect Loss | | | | | KAIZEN IDEA SHEET | | | | | | | | | | | |
|--|---|---|--|--|---|---|---|--|---|---|---|---|---|---|---|---|---|---|---|---|---|--|--|--|
| Welding lumps at at main member ,lower part & lower reinforcement joining due to heavy gap. | | | By providing copper plate at FF-30 main member,bottom reinforcement & lower part weld joint bottom side area. | | | | | Target : | | zero/month | | | | | | | | | | | | | | |
| W1 : Why To eliminate rejection for Welding lumps at main member ,lower part & lower reinforcement joining due to heavy gap. ? A1 : Co2 weld lumps at lower reinf & Y member weld joint W2 : Why Co2 weld lumps at lower reinf & Y member weld joint ? A2 : Gap observed at lower reinf & Y member. W3 : Why Gap observed at lower reinf & Y member. ? A3 : Create mannualy gap for main member assly insetion. W4 : Why Create mannualy gap for main member assly insetion. ? A4 : Mannualy error. | | | No Lumps at main member | | | | | What To Do : Check copper plate bolting & top surface. How To Do : Point added in daily JH check sheet. Frequency : Daily Cost Incurred For Making Kaizen : <table border="1" style="width: 100%;"> <tr> <th>Material Cost</th> <th>Labour Cost</th> <th>Total</th> </tr> <tr> <td>400.00</td> <td>180.00</td> <td>580.00</td> </tr> </table> Scope & Plan For Horizontal Deployment : <table border="1" style="width: 100%;"> <tr> <th>Equipmnet</th> <th>Target</th> <th>Status</th> </tr> <tr> <td colspan="3" style="height: 100px;"></td> </tr> </table> | | | | | Material Cost | Labour Cost | Total | 400.00 | 180.00 | 580.00 | Equipmnet | Target | Status | | | |
| Root Cause Mannually error. | | | | | | | | | | | | | | | | | | | | | | | | |
