Equipment :	Flight Bar	Loss Type :	Defect Loss							KAIZEN IDEA SHEET Kaizen ID : 530
	Department :	Maintenance	Result :	N	P	Q	C	D	S	M	
	Cell :	Electroplating	Type :								
Unit Name : 100211 - UMASONS AUTO COMPO PVT LTD, Aurangabad			Operation : Electroplating								
Kaizen Theme: To minimize yellow, burning and Peel off defects			Idea : Change the design of V black								
Problem / Present Status		Counter Measure		Benchmark :		15%					
Wrong design of V Block		V block design change (Compact V black made instead of allignment of 2 heads)		Target :		0

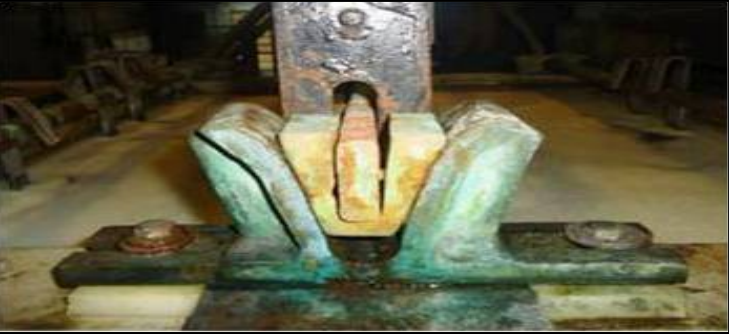
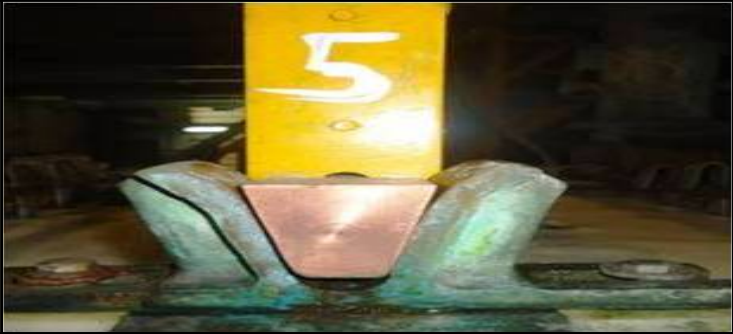
1. Satish Kangare		2. Arjun Lahane					
3. Pradip Nikam		4. Bhausahab Ambhore									
5. Sanklesh Bichare		6. Mukesh Patil									
Benefits											
C		Total rework cost minimized Rs 0.00									
Q		No customer complaint of Yellow, peel off and Burning Rs 0.00									
M		No need to PM Rs 0.00									
Why Why Analysis :		Result :		Kaizen Sustenance :							
W1 : Why Yellow, Burning and Peel off defects ? A1 : In-adequate current density W2 : Why In-adequate current density ? A2 : Loose contact between flight bar and V block W3 : Why Loose contact between flight bar and V block ? A3 : Loose contact between 2 heads of Male V block W4 : Why Loose contact between 2 heads of Male V block ? A4 : Allan bolting to heads of V block		No yellow, burning and peel off observed due to V block alignment problem

What To Do : Check by Chemist							
Root Cause Wrong designed				How To Do : Check sheet
